Mitt. naturwiss. Ver. Steiermark	Band 132	S. 43–62	Graz 2002
----------------------------------	----------	----------	-----------

The influence of landuse on the stability of slopes with examples from the European Alps

Von Andreas KELLERER-PIRKLBAUER¹
Mit 11 Abbildungen und 2 Tabellen

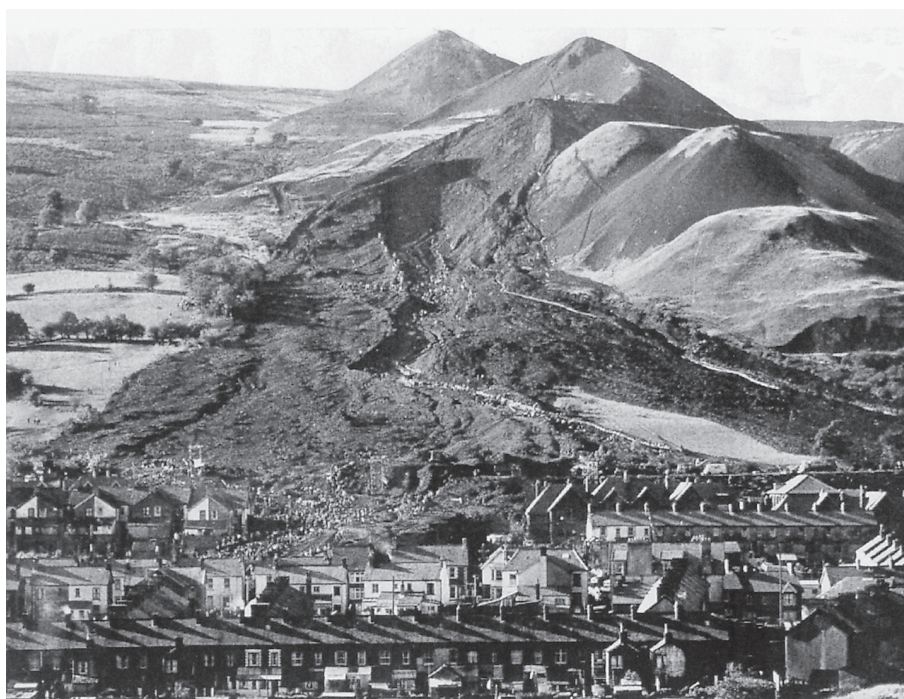
Fig. 1: Photograph to show the extent of the 1966 Aberfan landslide (JOHNES & McLEAN 1999).

Aberfan is a small town in Wales, situated in a coal mining area of the Welsh mountains. In this coal mining region, heaps of excavated debris from the coal mine were being piled on a hillside above the town. The spoil heaps or tips had been there for more than 20 years on top of the local Brithdir Sandstone, a highly porous rock layer. The sandstone contains many springs and several of the tips were placed above these springs. This had led to destabilization of some of the tips in 1944 and 1963 with the result of minor landslides. But at 9:15 a.m. on the 21st October 1966 on one of the seven artificial tips a huge slope failure occurred. About 160,000 m³ of coal mining waste slumped abruptly on the valley sides and flowed downhill at high speed. The front part of the debris became liquefied and moved as a series of viscous surges down slope. Approximately 120,000 m³ of debris were deposited on the lower slopes of the mountain and about 40,000 m³ came to rest in the urban area of Aberfan (Fig. 1). The landslide destroyed part of the town and killed 144 people (ALEXANDER 1993).

The tip consisted of mine waste debris in different grain sizes. High annual rainfalls, the disturbance of the natural drainage system, unstable slopes and the presence of fine grained so called "tailings" caused the failure in Aberfan (BOLT & al. 1975, WALTHAM

1978). In the case of Aberfan it was not a natural slope which failed, but a human built hill which suffered slope failure.

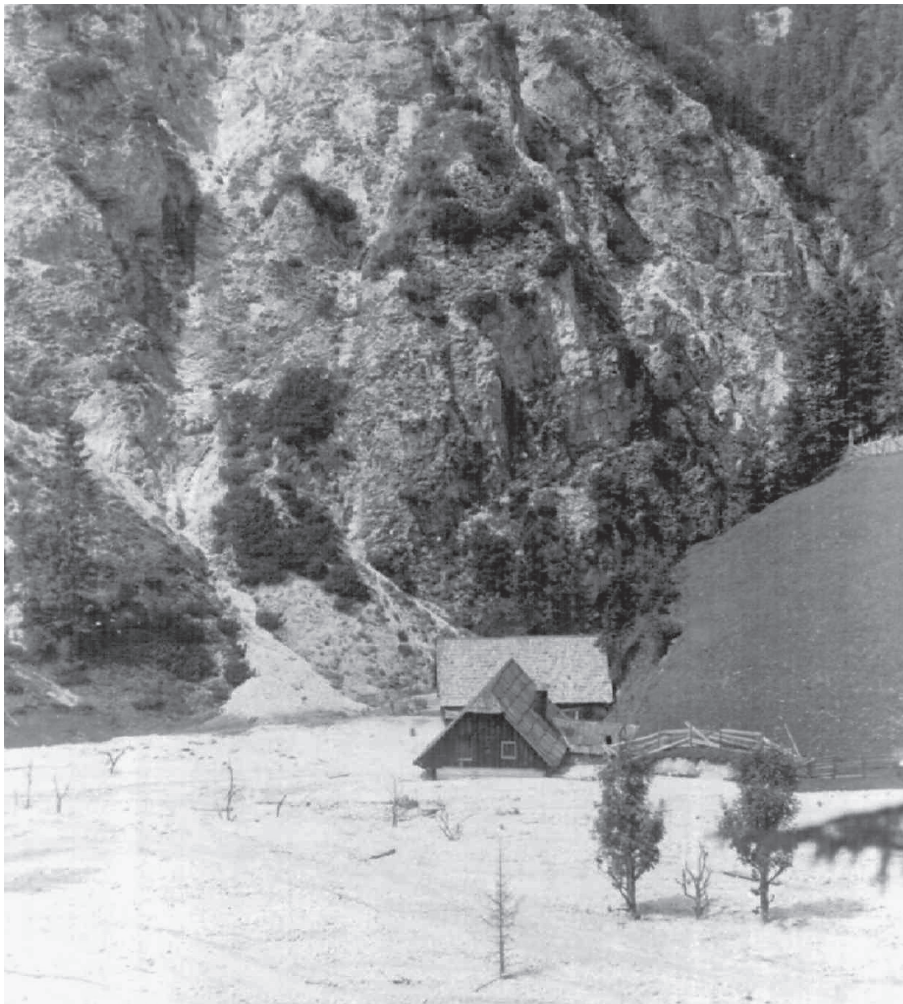
Fig. 3: Debris filled valley bottom of the Holzaepfel Valley around 1950. Note the partly buried buildings and the almost unvegetated steep slopes with debris cones in the background (by courtesy of WLV, Vienna, Austria).

Transported material from higher areas of the drainage catchment covered the agricultural land at the valley bottom with a thick layer of debris. Figure 3 shows the situation at the valley floor and the neighbouring hillside around 1950. Debris from the adjacent slopes and the side valley deposited on the valley floor, thereby destroying a farmhouse and the agricultural land around it. Clearly visible in the same figure are the almost unvegetated steep slopes behind the buildings. Today, a broad braided river is covering the whole width of the valley floor in some sections. No agricultural use of the valley floor is possible and most adjacent slopes are again covered with mature forest (Fig. 4). Yet, many slopes with till material depots, especially in the valley bottoms of small side

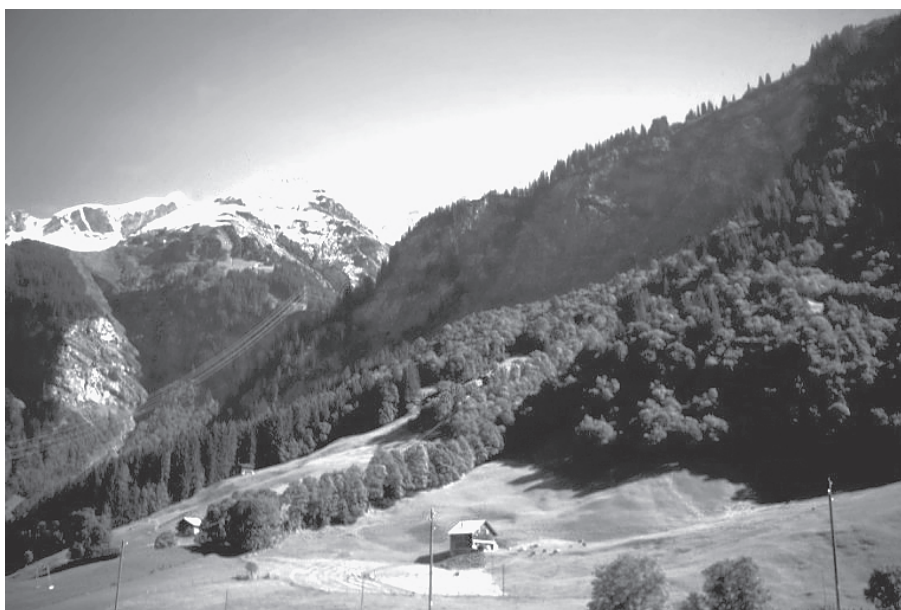
Fig. 8: The forest and meadow covered debris cone on the foot of the Plattenberg of the 1881 rockfall in Elm, Switzerland (SWISSFOT).

In 1881 a big human-induced rockfall happened near Glarus in eastern Switzerland. A large part of the Tschingelwand rock wall (also called Plattenberg) crashed down over 500 meters to the valley floor, where the mass changed its type of movement into a huge rock avalanche before stopping its movement near the village centre of Elm. Astonishingly the rockfall was almost entirely the work of man (WALTHAM 1978).
