Capturing the effects of the Danube River incision on the potential natural vegetation of the Donau-Auen National Park

Anna Schöpfer, MSc.

University of Natural Resources and Life Sciences, Vienna (BOKU)
Institute of Hydrobiology and Aquatic Ecosystem Management (IHG)

Vienna, November 2016

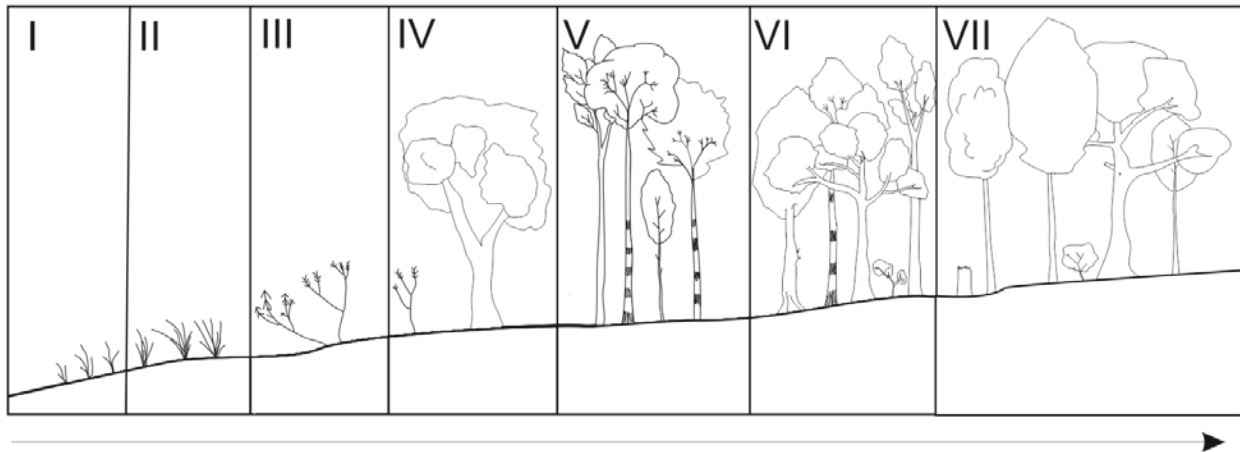
Succession ends as the forest reaches its climax. During ecological succession the biomass of the vegetation as well as the humus layer of the soil are increasing. Though succession is a unidirectional, disturbances such as floods and erosion, characteristic for floodplains, but also fire, drought and frost can interrupt or reset the process (Egger et al. 2009) (Fig. 2).

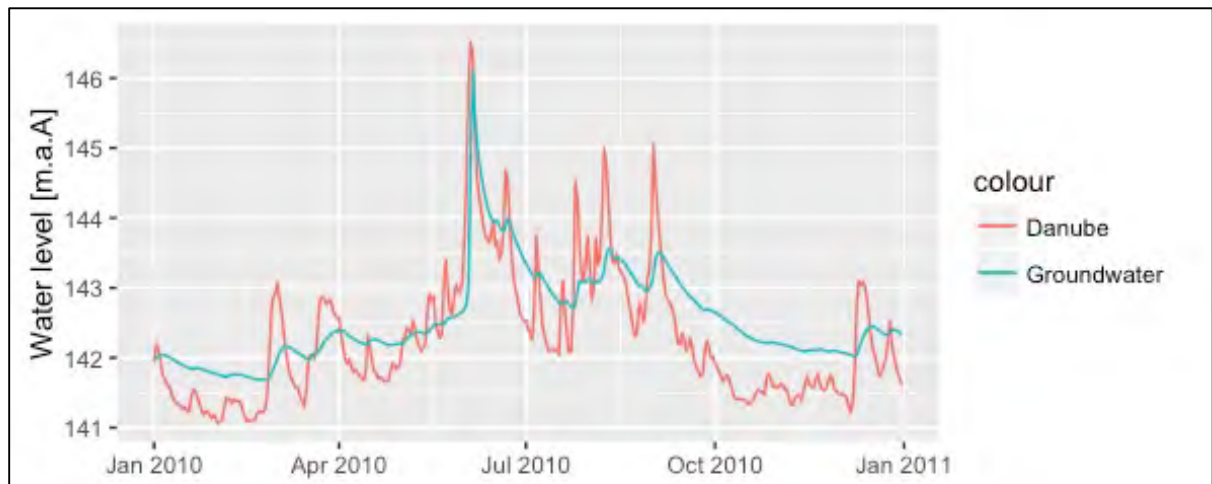
Figure 7 Water levels of Danube at *Wildungsmauer* and groundwater (Eckartsau, BI 1894.5) in 2010 (raw data: via donau)

The left riverbank of the national park is located on the *Marchfeld* aquifer. Under current climate the mean annual precipitation and evaporation are almost in balance. The groundwater level's main defining factor is the Danube's water level as the aquifer is recharged via seepage from the river (Blascke 2006). A comparison of the mean daily water level at *Wildungsmauer* and groundwater level at its closest gauging station, *Eckertsau, BI 1894.5*, shows the groundwater table rising and falling with the Danube level (Fig. 7).

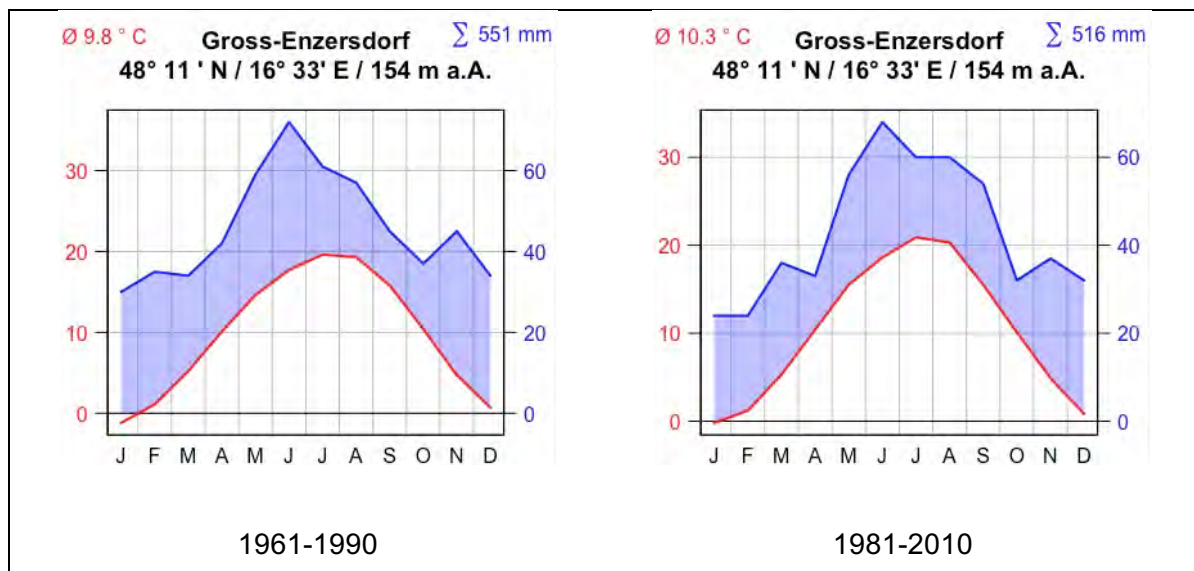
Figure 8 Walter-Lieth diagram *Groß-Enzersdorf* (raw data: ZAMG)

For the period 1981-2010, the mean temperature at the closest meteorological station *Groß-Enzersdorf* is 10.3°C and the annual precipitation is 516 mm. Compared to the period 1961-1981 the temperature has increased by 5°C and the precipitation decreased by 35 mm (data source: ZAMG). The Walter-Lieth diagram generated for *Groß-Enzersdorf* illustrates that the climate is humid and the vegetation period starts ~ 1st April and ends ~ 31st October (Fig. 8).

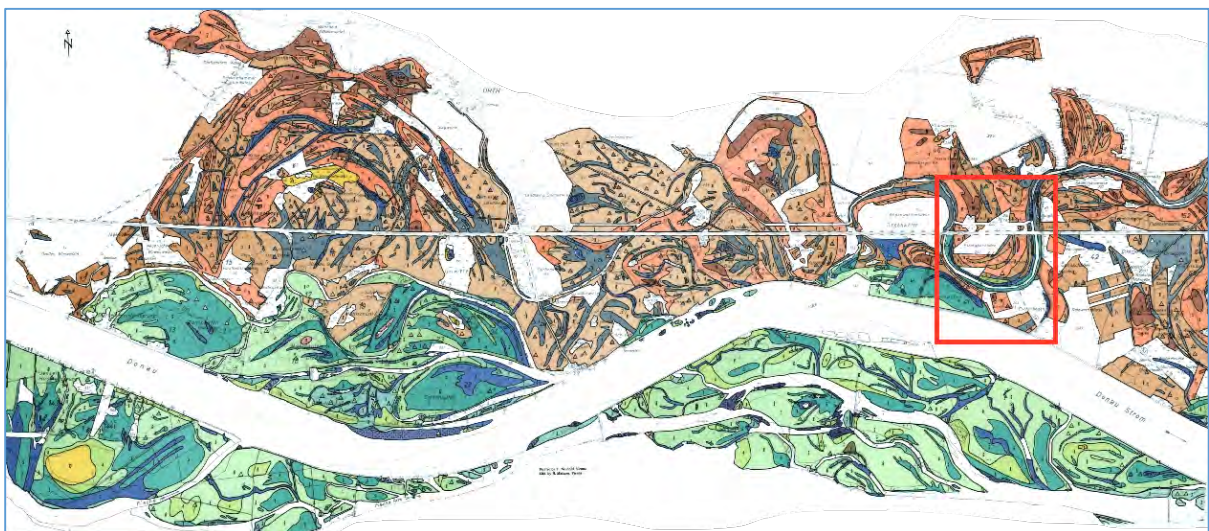
Figure 9 Potential natural vegetation of 1975 (Margl und Müller 1975)

The potential natural vegetation of the Danube floodplain mapped in 1975 is shown Fig. 9. The study site, indicated with the red square, was mapped by Hermann Margl and Müller (1975).

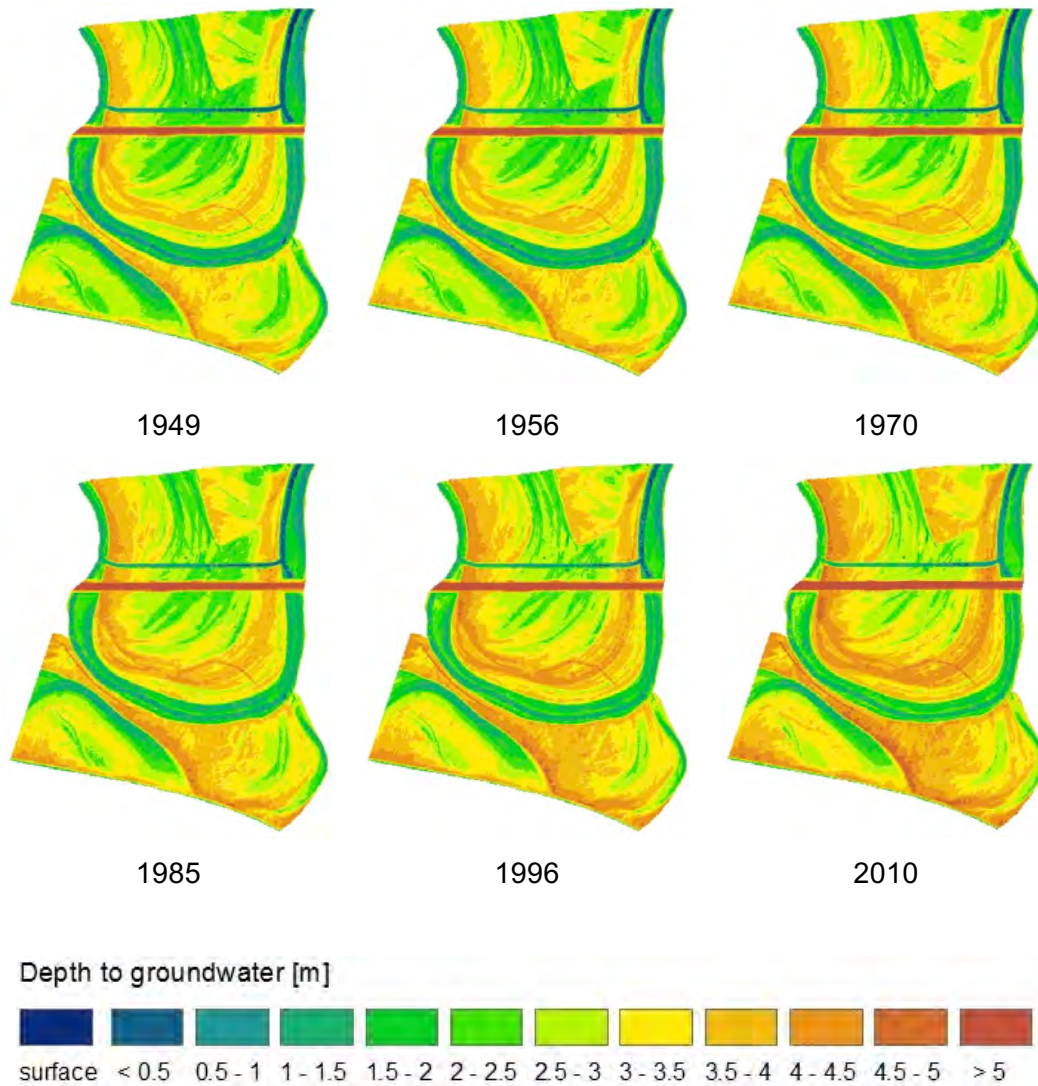
Figure 14 Map of modelled mean depth to groundwater in meters at the study site between April and October in 1949, 1956, 1970, 1985 and 2010 (raw data: via donau)

Fig. 14 illustrates maps stating the depth to groundwater at the study site as modelled for the SMW of each investigated year.

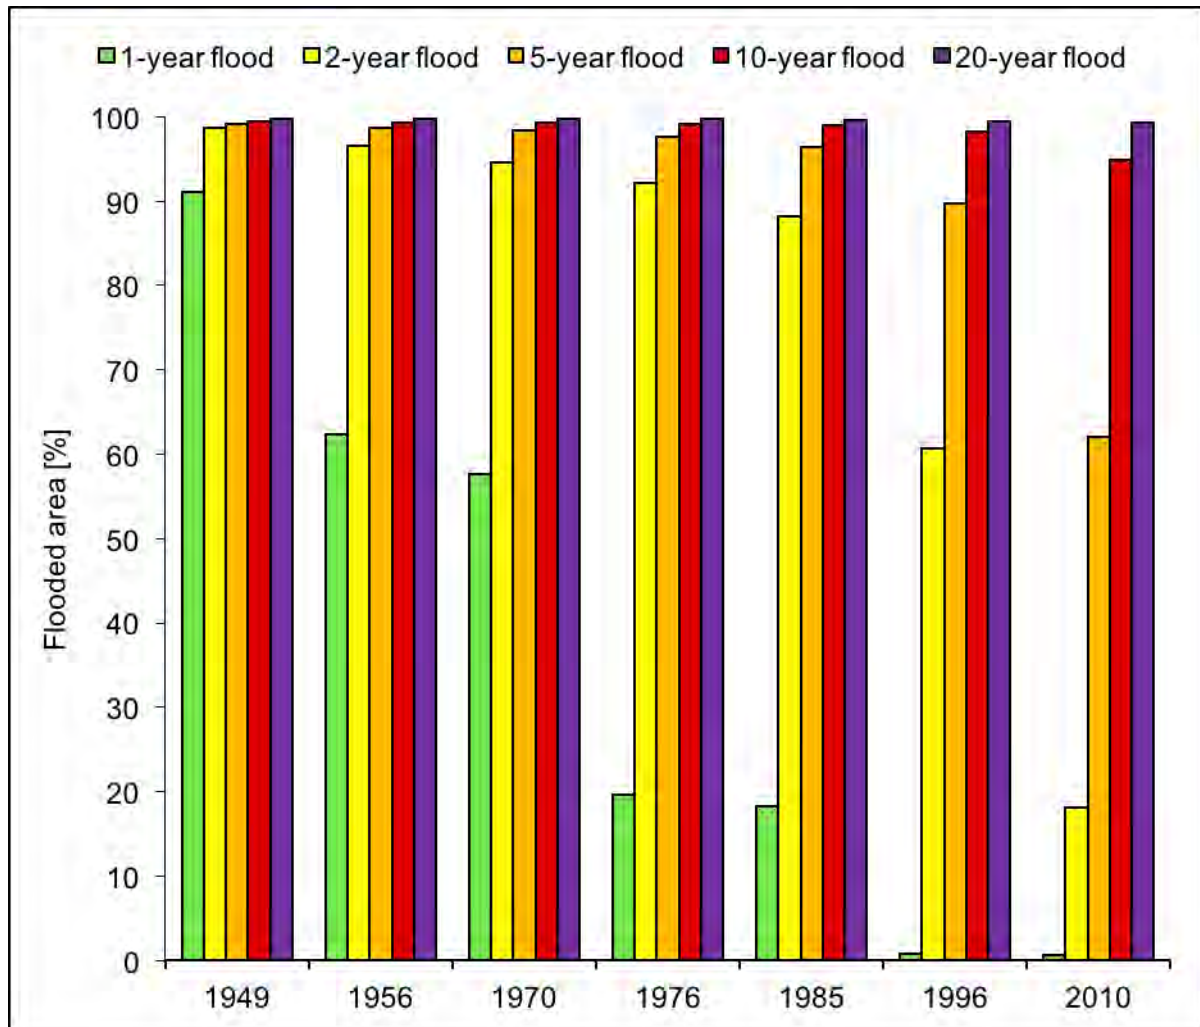
Figure 18 Modelled flooded area of the study site in m² for the 1-year flood, 2-year flood, 5-year flood, 10-year flood and 20-year flood in 1949, 1956, 1970, 1976, 1985, 1996 and 2010 (raw data: via donau)

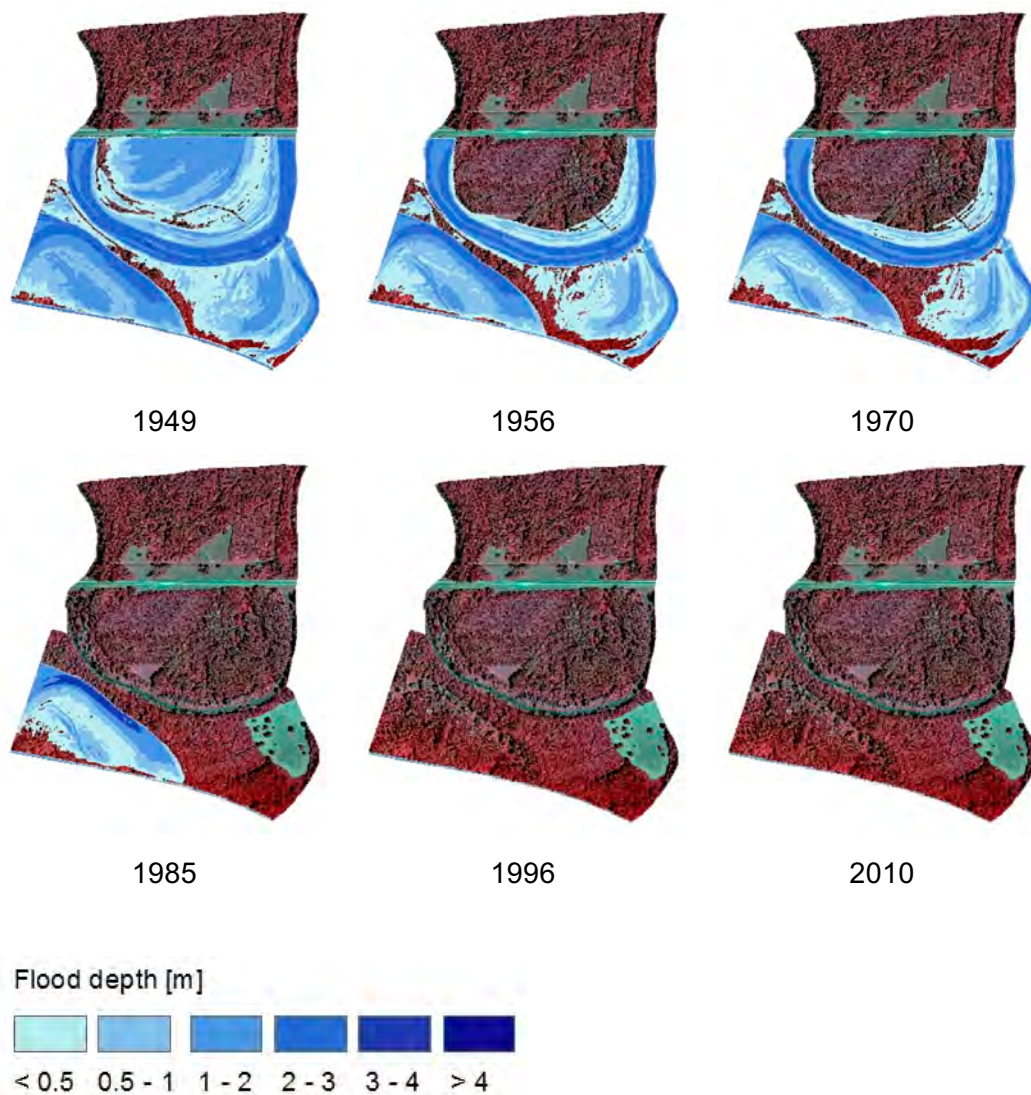
Figure 19 Modelled flood depth (inundation) in meters during a 1-year flood at the study site in 1949, 1956, 1970, 1985, 1996, 2010 (raw data: via donau)

The maps in figure 19 illustrate the flood depth during a 1-year flood event modelled for six investigated years. The shares of low depths of inundation increases over the years and high depths of inundation are less frequent 1949 than 2010 (Fig. 20). For example, the inundation depth 2 m to 3 m has a share of 16.86% in 1949, only 0.05% in 2010 (Table 6).

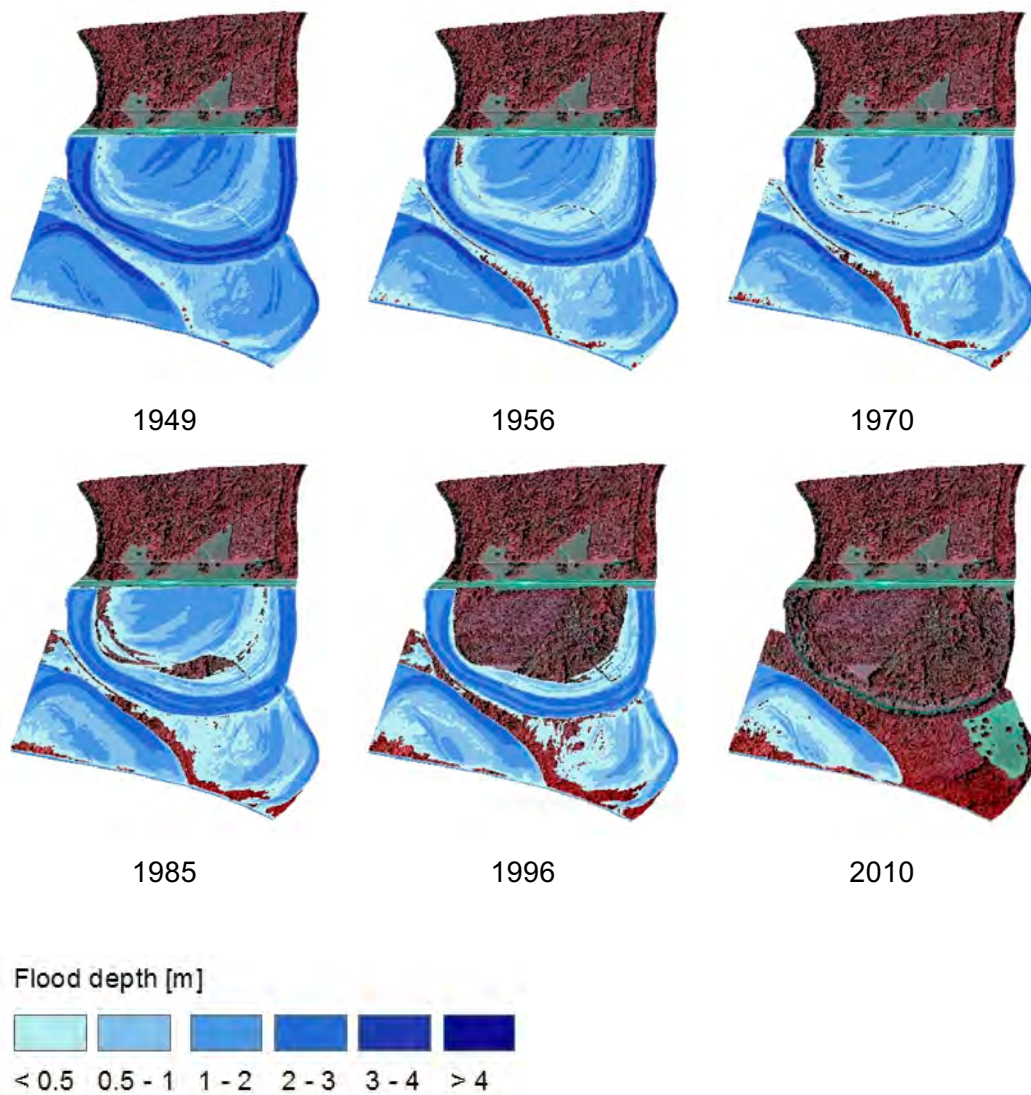
Figure 21 Modelled flood depth (inundation) in meters during a 2-year flood at the study site in 1949, 1956, 1970, 1985, 1996,2010 (raw data waterlevel, discharge: viadonau 2013, raw data: flood events: via donau 2014, raw data elevation: Donau-Auen National Park)

The characteristics of 2-year floods concerning area and inundation depth also changed over the year (Fig.21). The share of each depth class on the area between inundation dam and river are presented in Fig. 22. While in 1949 8.62% were flooded at a depth ranging from 3 m to 4 m, the share decreased to 2.98% in 1970. In 2010 no area is flooded at this depth range. The flood depth range, which has the largest fraction in 1949 is 1 m to 2 m and occupies 44.82% in 1949, 34.36% in 1970 and 25.18% in 2010 (Table 7).

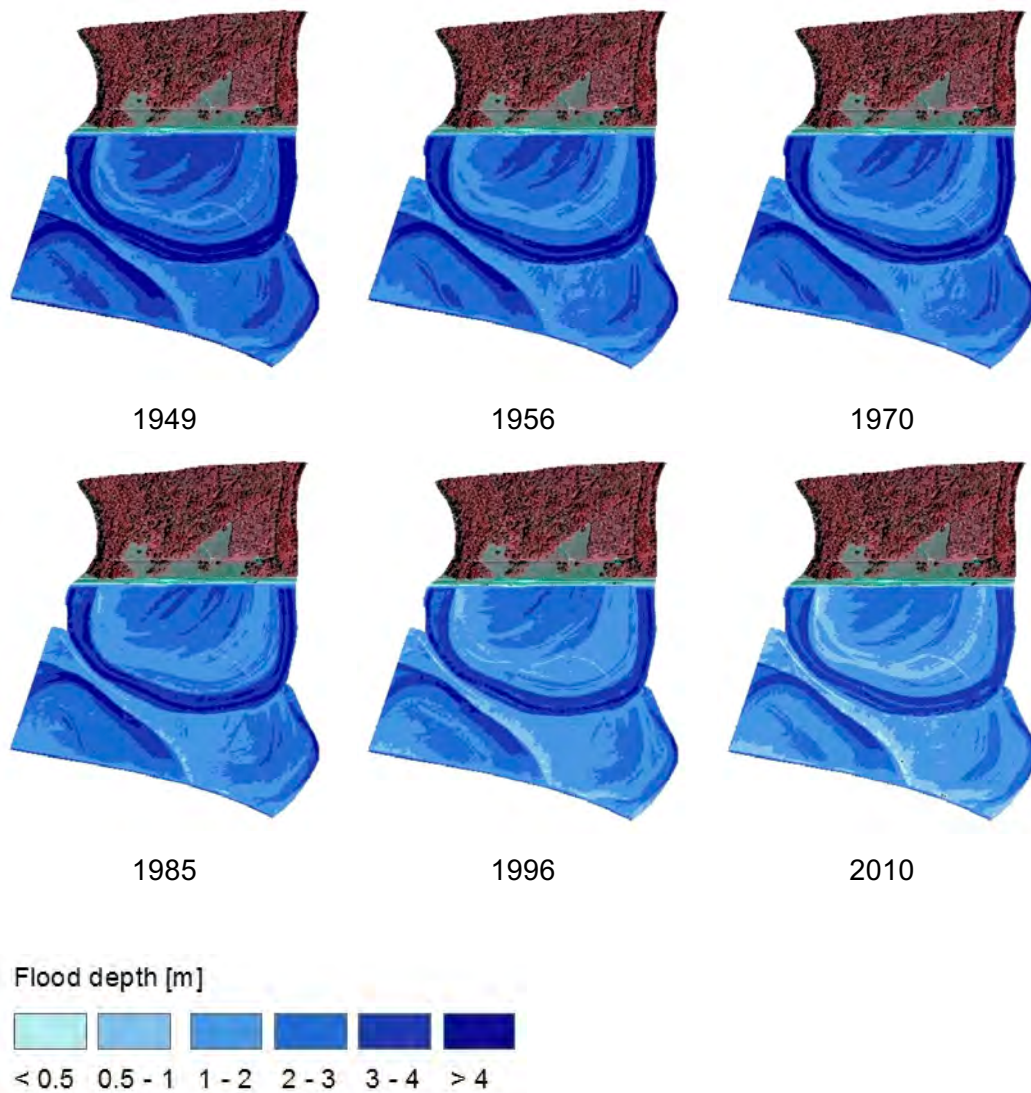
Figure 27 Modelled flood depth (inundation) in meters during a 20-year flood at the study site in 1949, 1956, 1970, 1985, 1996, 2010 (raw data: via donau)

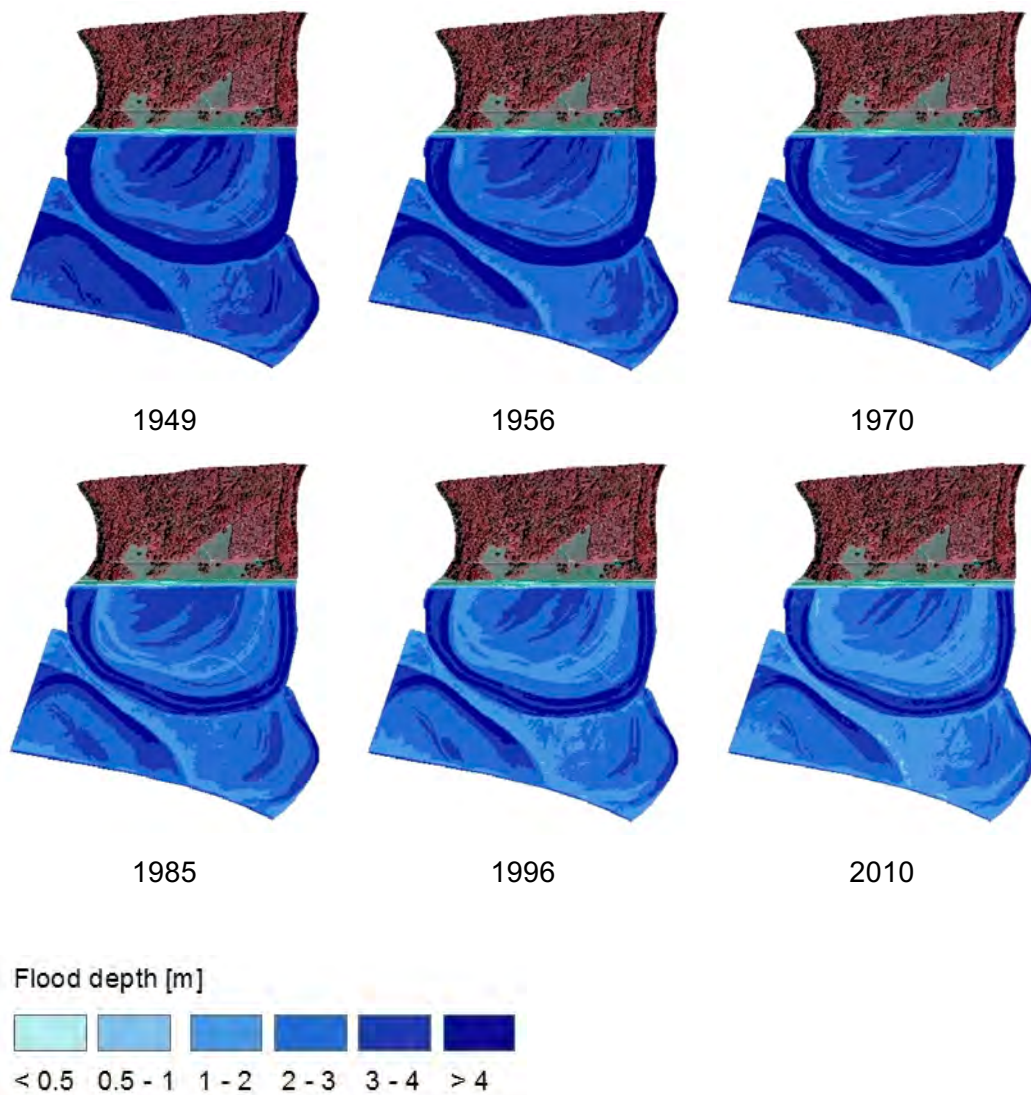
Figure 29 Modelled flood depth (inundation) in meters during a 50-year flood at the study site in 1949, 1956, 1970, 1985, 1996, 2010 (raw data: via donau)

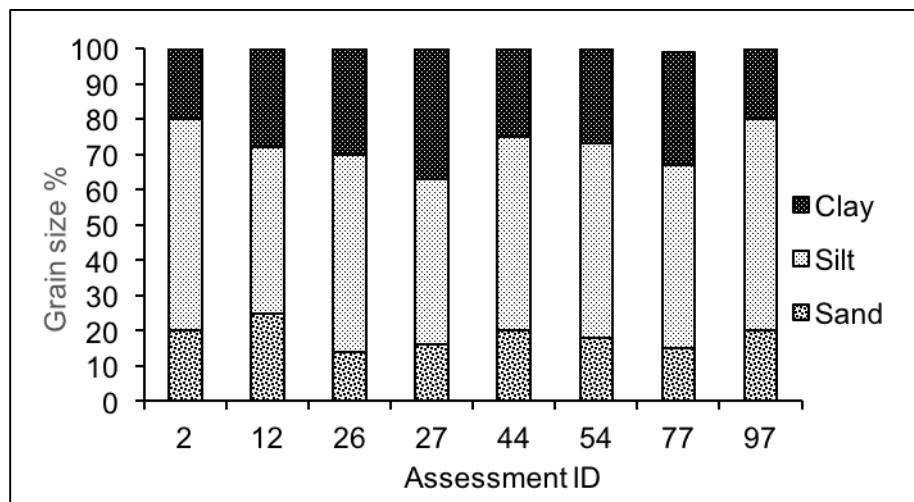
Figure 40 Grain size distribution at assessment sites

On the study site *Fresh willow woodland* is only found on the levee. The topsoil layer has a thickness of about 3 cm and the soil moisture is moist. The floodplain soil is categorized as grey floodplain soil (Table 21). The upper layer of the soil features 55% sand, 40% silt and 5% clay. Thus, the soil texture type is *Sandy Loam* (Fig. 40).

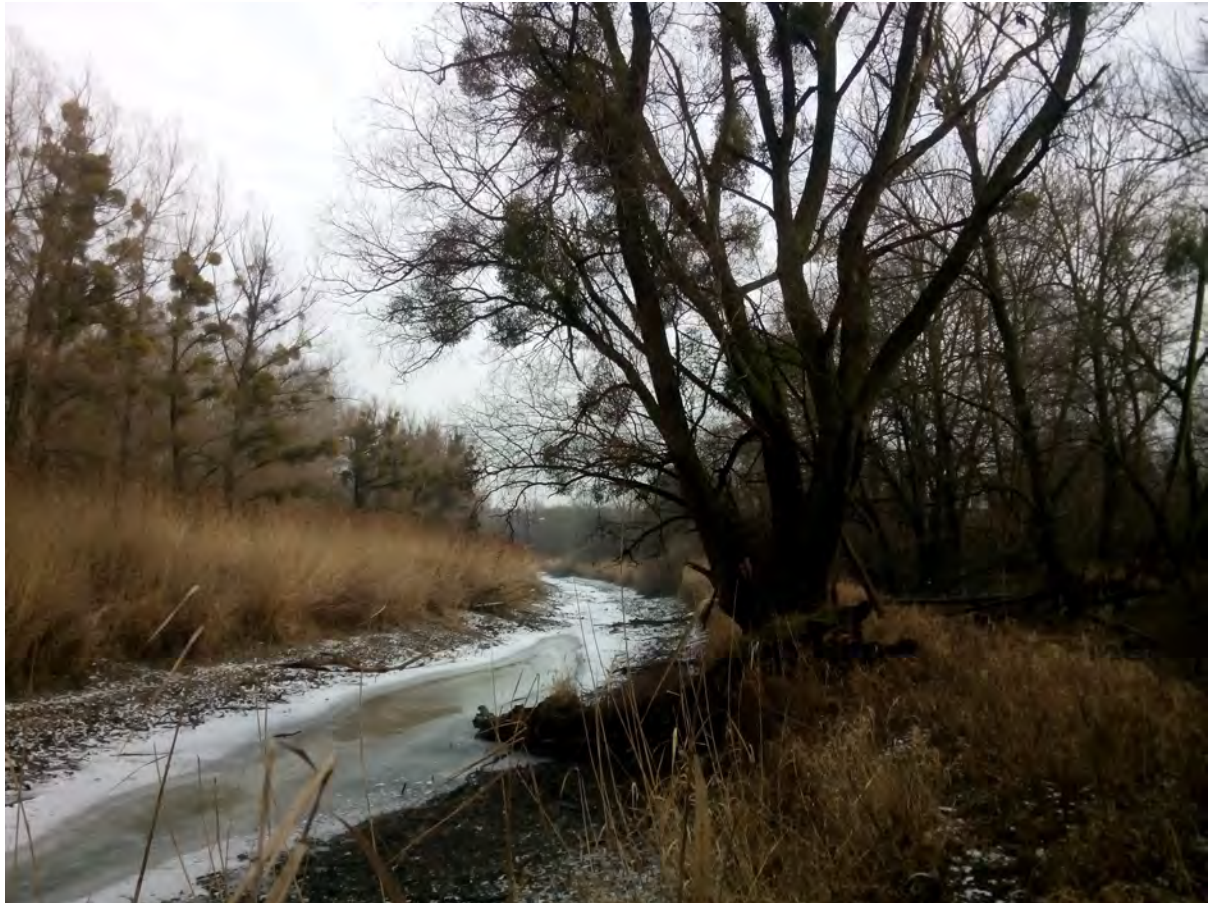
Meander cutoff of *Faden* is fed by groundwater pulse during flood event 2016
