# Fluvial processes and changes in the floodplain vegetation of the Vjosa river (Albania)

Nils RÖSSLER, Gregory EGGER & Anton DRESCHER

## **RÖSSLER N., EGGER G. & DRESCHER A., 2018: Flussmorphologische Dynamik und Vegetation im Inundationsgebiet der Vjosa (Albanien).**

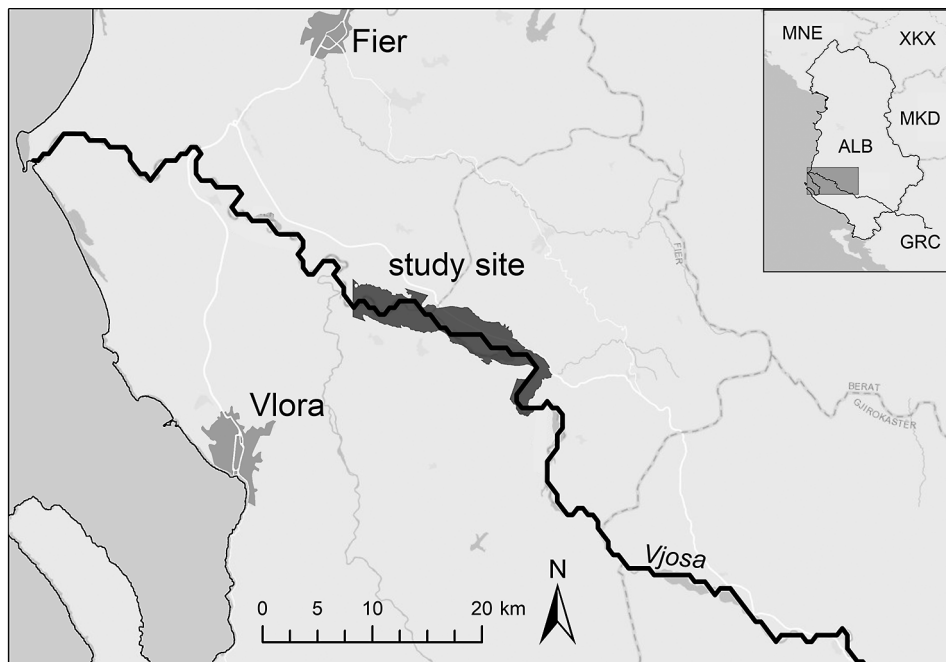
Fig. 2: Survey area of comprehensive field mapping (ALB: Albania, MNE: Montenegro, XKX: Kosovo/Serbia, MKD: Macedonia, GRC: Greece). – Abb. 2: Lage des Kartierungsgebietes (ALB: Albanien, MNE: Montenegro, XKX: Kosovo/Serbien, MKD: Republik Nord-Mazedonien, GRC: Griechenland).

(Fig. 2). The stream range is approx. 31.5 km long, the average width of the near-natural river landscape corridor is approx. 1.5 to 2 km, covering approx. 1380 ha, or 3170 ha including agricultural fields within the morphological floodplain.

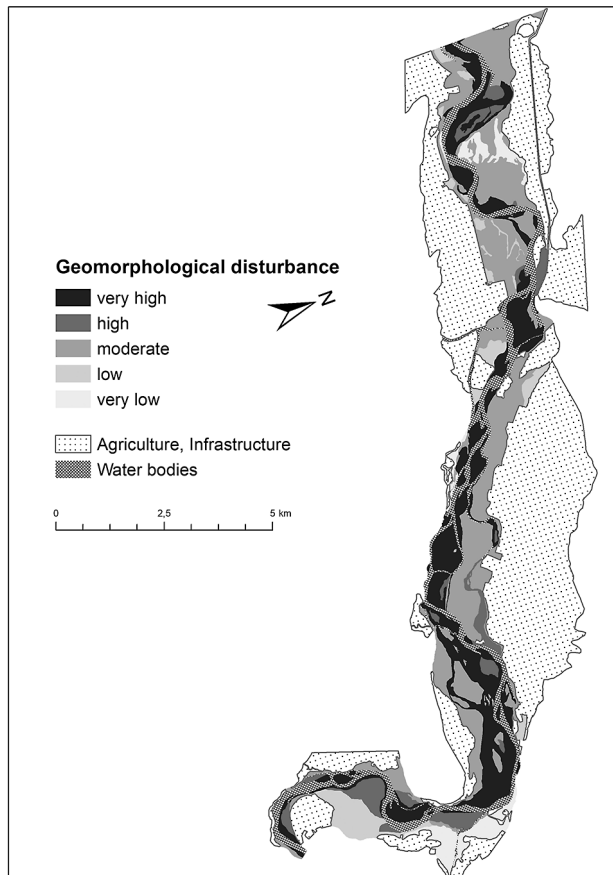
Fig. 3: Geomorphodynamic disturbance along the Albanian Vjosa River (modified from RÖSSLER 2017). – Abb. 3: Verteilung der Flächen gleicher geomorphodynamischer Störungsklassen im Kartierungsgebiet der Vjosa (modifiziert nach RÖSSLER 2017).

More than half of all mapped vegetation types related to the reviewed floodplains were characterized by their high to very high geomorphodynamic disturbance (very high 46 %, high 13 %). Almost one third was covered by moderate disturbance, where a thin layer of litter and humus was detected. The remaining vegetation types are characterized by mor-

phodynamics that have already been interrupted for a long time, leading to an advanced stage of soil evolution (class low and very low each 5 %) (Fig. 3).

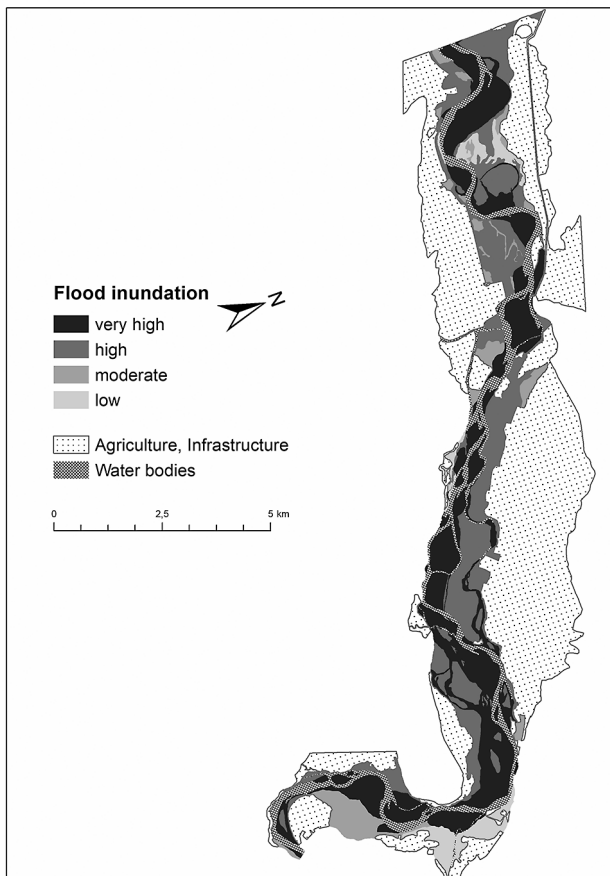
Fig. 4: Flood inundation of the study site (modified from RÖSSLER 2017). – Abb. 4: Verteilung der Flächen gleicher Überflutungshäufigkeit und -intensität im Kartierungsgebiet der Vjosa (modifiziert nach RÖSSLER 2017).

Mostly, flood inundation of gravel banks, pioneer vegetation and Oriental plane pioneer shrubs was very high. All other vegetation types were also characterized by mostly high and moderate flooding impact, whereas the forests predominantly showed minimal flooding impact (Fig. 4).

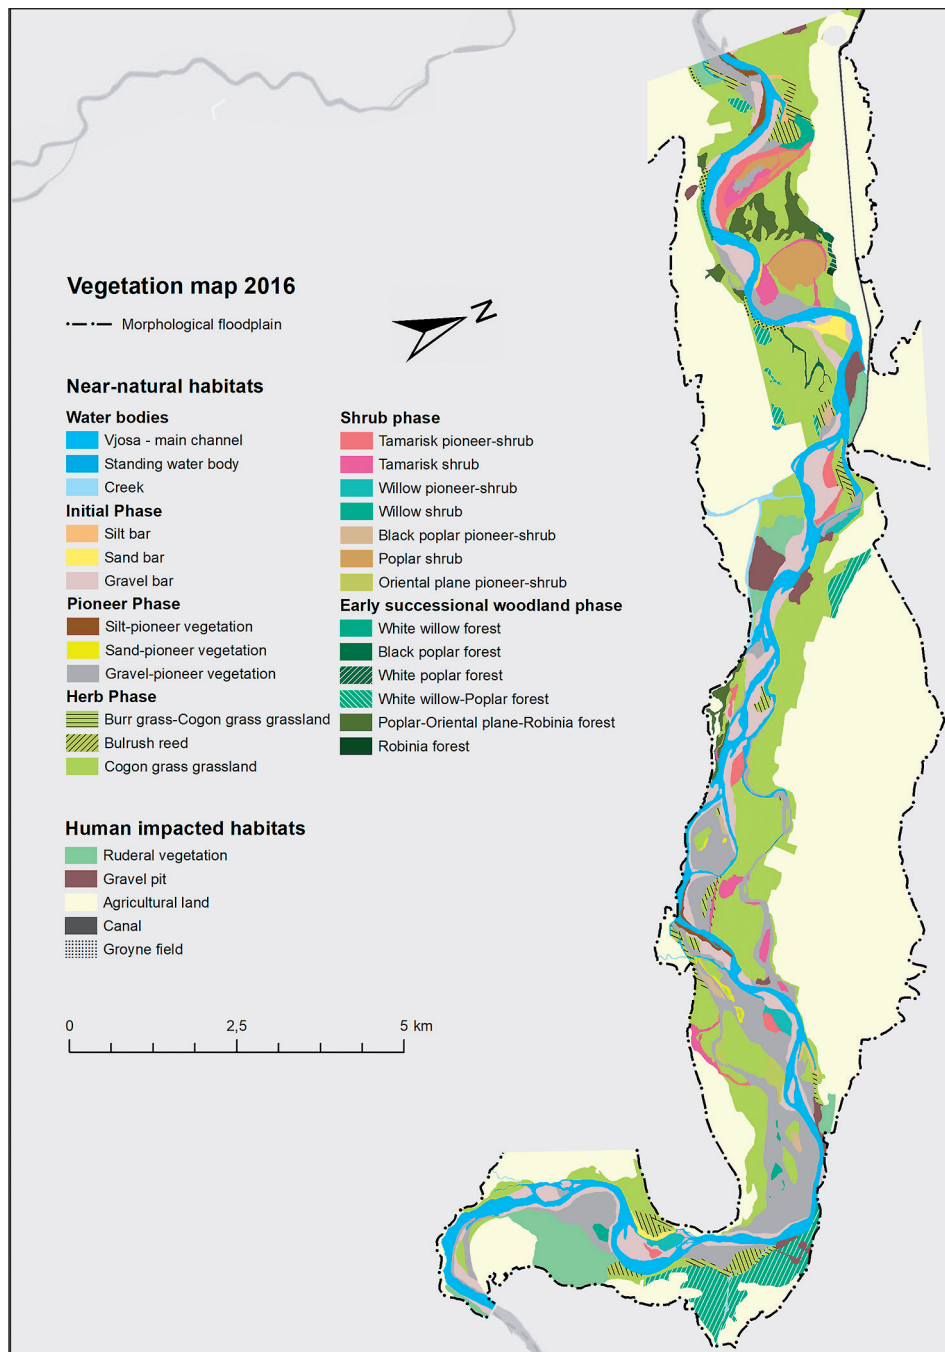
Fig. 5: Map of current vegetation (modified from RÖSSLER 2017). – Abb. 5: Karte der realen Vegetation des Untersuchungsgebietes (modifiziert nach RÖSSLER 2017).

vegetation (265 ha, 19 %) along both the main stream and the repetitively shifting anabranches (Fig. 5). Within these pioneer stages dominated by herbs and shrubs, typical woody species are white, purple and rosemary willow (*Salix alba*, *S. amplexicaulis*, *Salix eleagnos*), smallflower tamarisk (*Tamarix parviflora*), white and black poplar (*Populus alba*, *P. nigra*) and oriental plane (*Platanus orientalis*). These woody pioneer species stabilize the substrate and lead to a further sedimentation of fine grained sediments. This leads to a more or less dense bushland on stands without extremely high morphodynamics (height 1 to 3 m). This pioneer bushland occurs with changing species composition and alternating dominance and cover, both as a mixed inventory and as a mosaic with alternating dominance conditions, and covers approx. 10 % (140 ha) of all near-natural plains.

Slightly more than half (1644 ha) of the almost 32 km<sup>2</sup> of comprehensively mapped reference section of the morphological floodplain are covered by agricultural fields and grasslands (Fig. 5). They are located on a higher floodplain level and are accompanied by near-natural plains crucially affected by floods in central parts of the floodplain area. They are characterized by broad and annually repetitively shifted topographic surfaces of non-vegetated gravel bars (171 ha, 12 % of near-natural banks) and pioneer

within the morphologic floodplains shows an increase of approx. 176 ha or 12 % (from 1468 ha to 1644 ha) regarding areas used intensively for agriculture (Fig. 5). Also, areas of open gravel bars, pioneer vegetation and herbs increased by approx. 130 ha or 13 % (from 970 ha to 1100 ha). In contrast, bushland decreased by nearly 70 ha or 30 % (from 211 ha to 140 ha). Floodplain forests show the most obvious loss of area. Here, within the last 35 years, a reduction of 354 ha took place – that equals almost one quarter of the original area in 1980 (from 491 ha to 137 ha). The detailed analysis shows that the lost forest area was intermediately grubbed up and transformed into both crops and grasslands for intensive agricultural use (104 ha) or into cogon grass meadows for extensive grazing (180 ha) (RÖSSLER 2017).

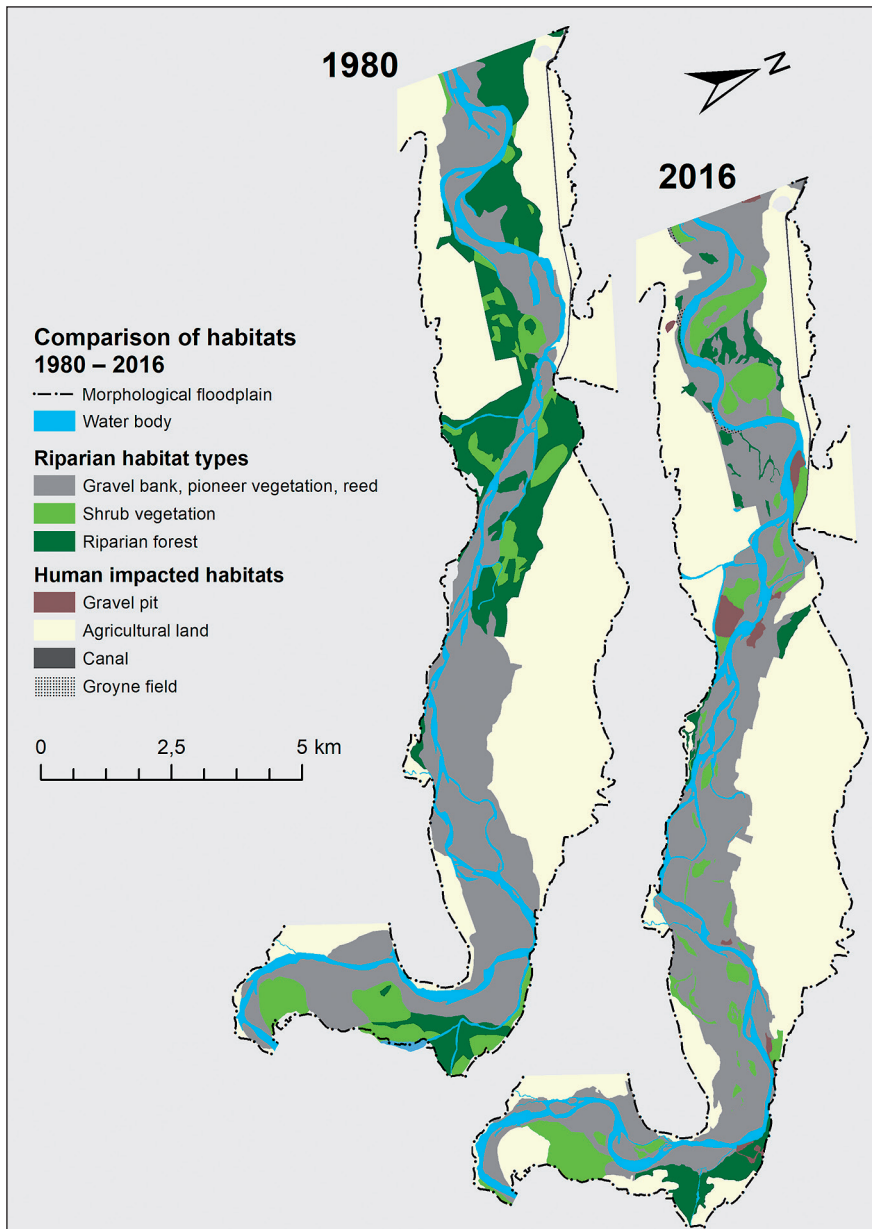
Fig. 6: Habitat maps from 1980 (Original map source: Mapbasis: People's Socialist Republic of Albania, State system of coordinates; KESH & SOGREAH CONSULTANTS 2008) and 2016 (modified from RÖSSLER 2017). – Abb. 6: Habitat Karten von 1980 (Original: Volksrepublik Albanien, Staatliches Koordinatensystem; KESH & SOGREAH CONSULTANTS 2008) und 2016 (modifiziert nach RÖSSLER 2017).

The Vjosa stream course has probably been relocated within the active channel, and former side channels are now desiccated and new ones have been formed. However, the total area of water bodies has remained roughly the same. This indicates that processes of river

bed forming did not change over a longer period and is also an indicator of, as yet, sparsely changed morphodynamics (Fig. 6).
