GeoZS – Landslide Issues in Slovenia and Contribution to the SafeLand Project Stože Landslide

M. ČARMAN & Š. KUMELJ

Geological Survey of Slovenia, Dimičeva ulica 14, 1000 Ljubljana, Slovenia.

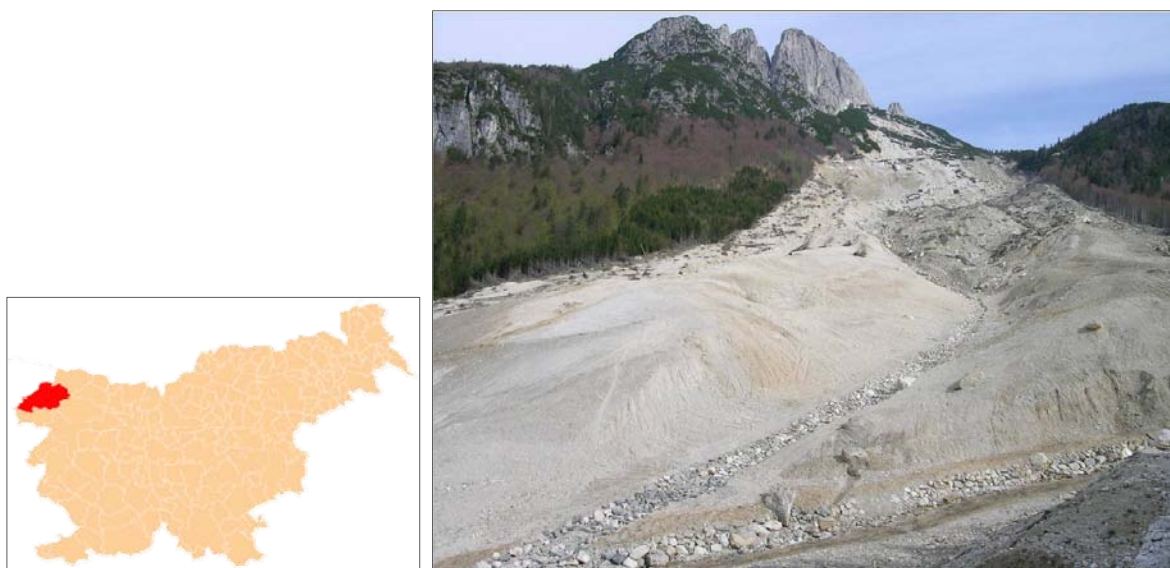
Fig. 2: Left – municipality Bovec, where landslide Stože is located.
Right – slope, where landslide Stože was "triggered" (Photo: M. ČARMAN, 2009).

Our contribution to the SafeLand project in the Area 4 will be performed on the Stože landslide, which occurred in November 2000 in the NW of Slovenia, in the Bovec municipality, under the Stože mountain (Figure 2). In the lower part of the slope, at the bottom of a small valley, runs a torrent named Mangartski potok. The first landslide movement (which was triggered by very intense rainfall) dammed up the torrent, resulting in a huge debris flow which flooded the village of Log pod Mangartom 4 km downstream. By its size, this was one of the largest events in Slovene history (materials from an area of over 25 hectares were displaced and deposited over more than 15 hectares). The consequences were catastrophic, with 7 casualties and huge material damage (MAJES, 2001).
