GEOLOGICAL CONTROLS ON SLOPE DEFORMATIONS IN THE KÖFELS ROCKSLIDE AREA (TYROL, AUSTRIA)

Christoph PRAGER^{1,2)}, Christian ZANGERL¹⁾ & Thomas NAGLER³⁾

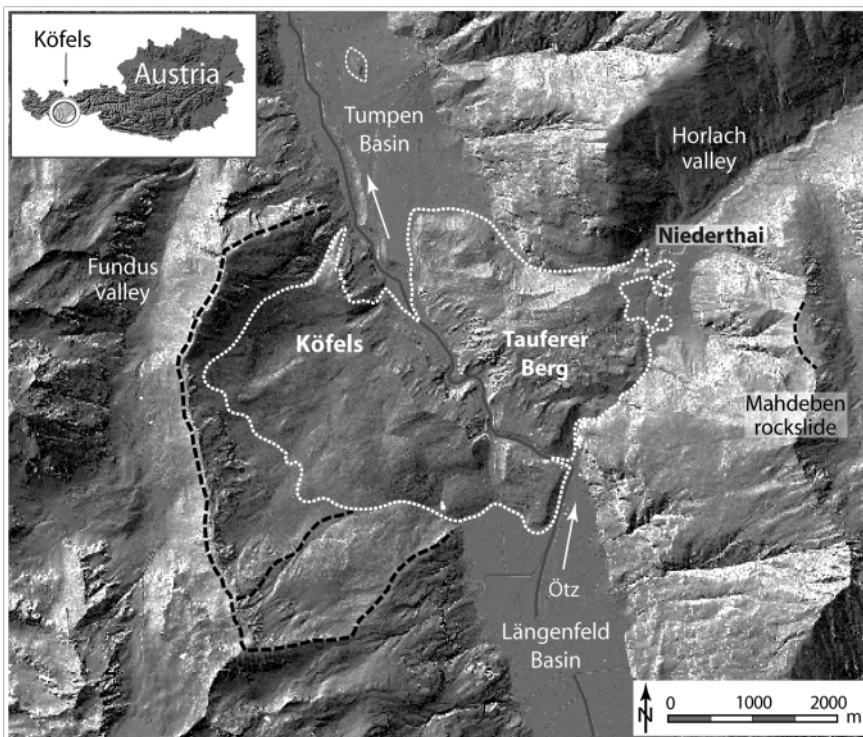
FIGURE 1: Shaded relief map (airborne laserscanner image; Tiris, 2009) showing the scarp (black stippled) and accumulation area (white stippled) of the Köfels rockslide, as well as the backwater areas in the Ötztal valley (Tumpfen and Längenfeld basin) and Horlach valley (Niederthai area). Note isolated Toma hill in the Tumpfen basin (location Lärchenbühel).

The Köfels rockslide detached along an east-facing slope from the mountain ridge between Wenderkogel (2200 m) and Pt. 2733 m (near Hohe Seite, 2852 m), leaving a giant amphitheatre-shaped niche (Figs. 1-3). The accumulated debris, covering at least 11.5 km², blocked both the main Ötz valley and the opposing mouth of the W-trending tributary Horlach valley, making up the huge debris ridge of the Taufererberg (Wolfs-egg 1680 m; Figs. 1, 4).

Another striking feature of the Köfels rockslide mass is the occurrence of widely spread rockslide-dammed backwater-deposits (Fig. 1). In the southerly adjacent Längenfeld basin, the extensive geological subsurface investigations for an abandoned hydropower project showed that the fluvio-lacustrine deposition sequences accumulated here up to at least 135 m thick, comprising fine-grained backwater sediments of up to 92 m in thickness. Reflection seismic measurements yielded evidence that the

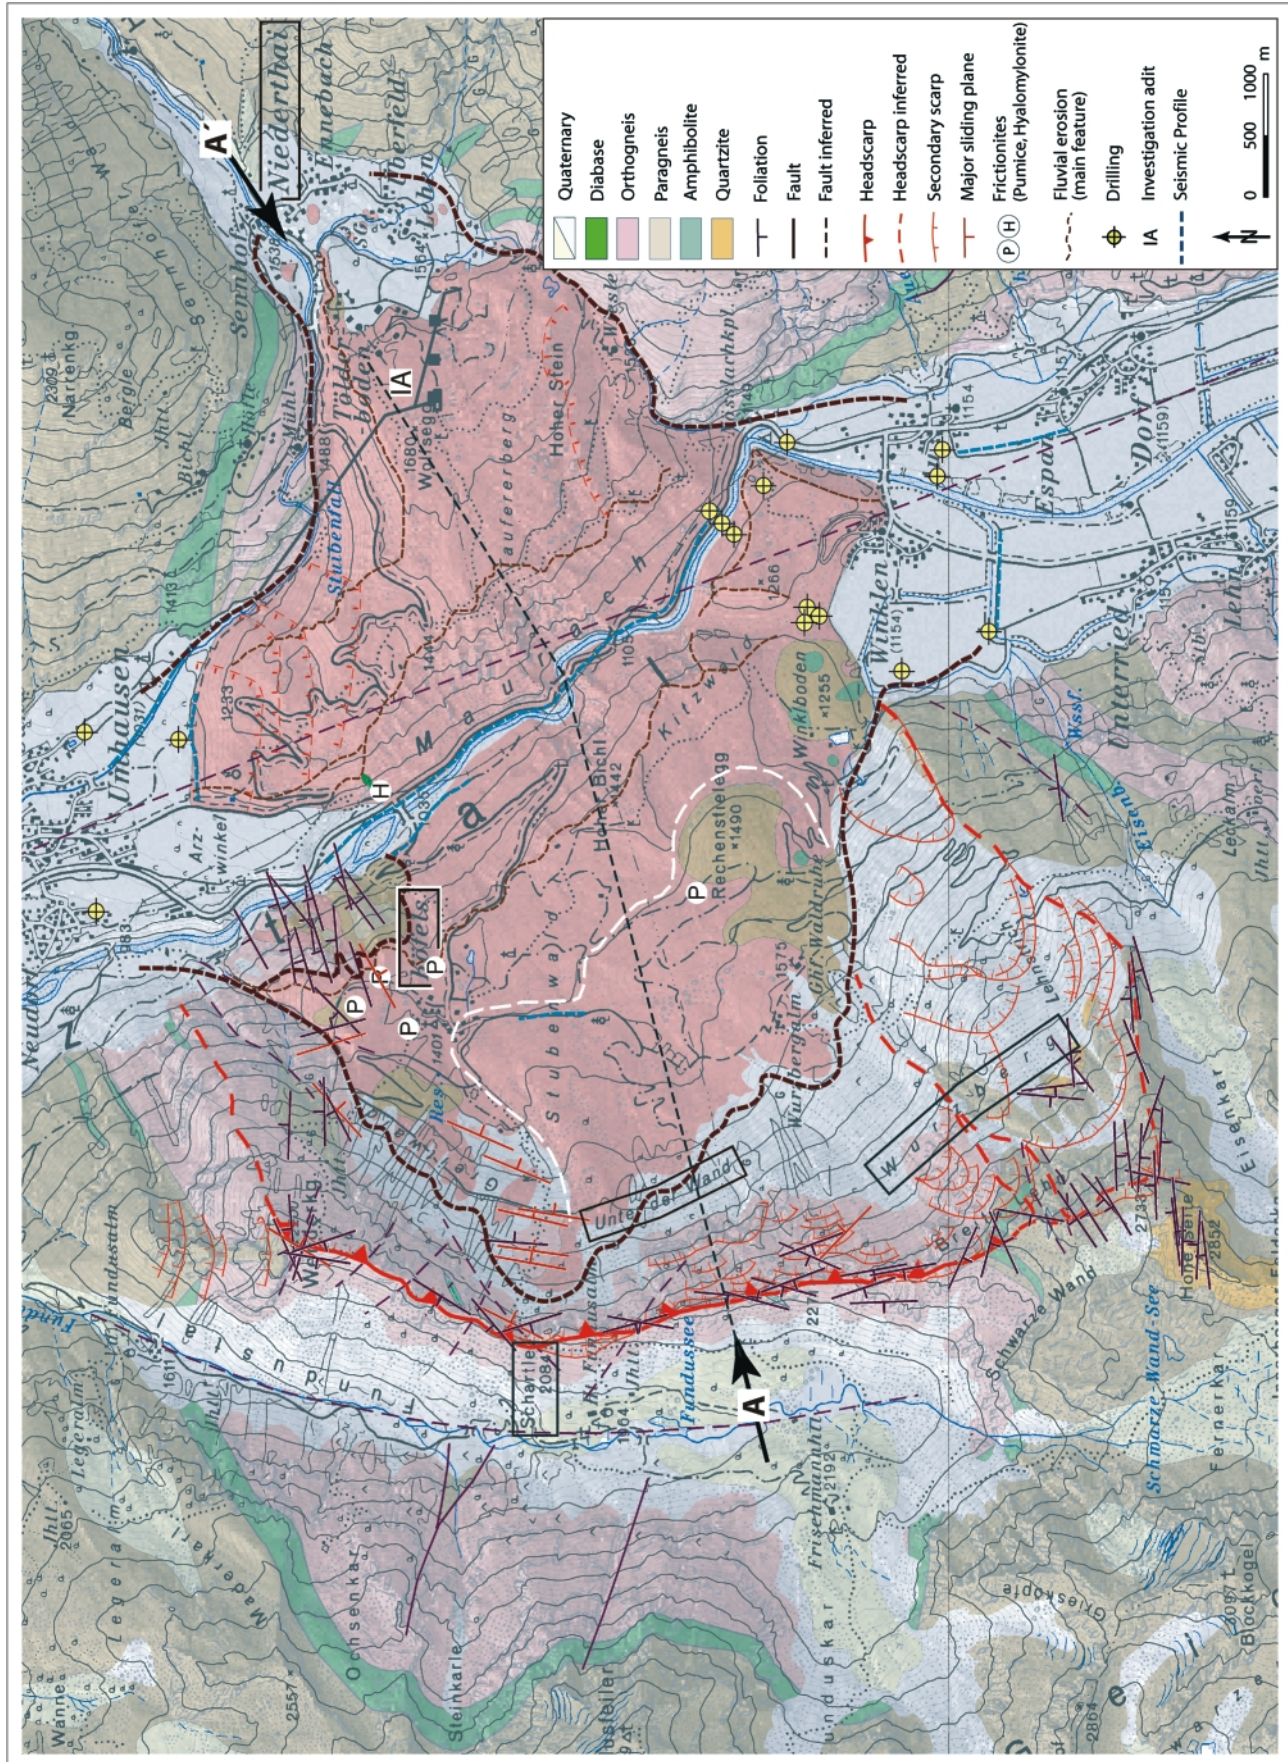
FIGURE 2: Geological map of the Köfels rockslide area. Frictionites (Preuss, 1974; Masch et al., 1985), drillings (Kleblsberg, 1951; Brückl et al., 2001), investigation adit (IA) Horlach valley, i.e. place of finding of C-14 dated wood fragments buried by the rockslide deposits (Heuberger, 1966) and seismic lines (Brückl et al., 2001) depicted according to the references cited. Displaced rockslide masses enveloped stippled dark red; inferred secondary failure event southwest of Köfels (white stippled) according to Hermanns et al. (2006) and own observations. A-A': cross-section (Figs. 9, 10).

Detail lithological and structural mapping led to a comprehensive geological map of the scarp and accumulation area of the Köfels rockslide (Fig. 2). The geological field data were completed by analysing optical colour images and airborne laserscanner images (Tiris, 2009) as well as geological cross-sections. The topographic surface lines of latter were derived from high-resolution airborne laserscanner data (LiDAR), with an accuracy of at least 1 measurement point per 1 m² at elevations up to 2000 m asl and 1 point / 4 m² above 2000 m asl respectively (Amt der Tiroler Landesregierung, flyover 2006), and yielded valuable information concerning the morphological and structural characteristics of the rock slopes deformation behaviour.

In the Köfels area the slope bedrock is comprised of three major lithological and structural bedrock units, all several hundred metres thick, which are i) a paragneiss series including amphibolites in the Wenderkogel area and further north, ii) a granitic orthogneiss complex in the northern to central scarp area, extending from Wenderkogel in the north to Wurzburg in the south and iii) another paragneiss series including amphibolites and quartzites, extending from Wurzburg to Hohe Seite in the south (Fig. 2).

Radiocarbon dating of buried wood, found in the investigation adit Horlach valley (Fig. 2), and surface exposure dating of rockslide boulders indicate that the Köfels rockslide event occurred in the early Holocene at about 9800 yrs and was succeeded by at least one minor event (Ivy-Ochs et al., 1998; Kubik et al., 1998, 2007). In view of these data and morphological features, Hermanns et al. (2006) roughly differentiated between two slide masses: firstly a major event accumulating in the Taufererberg area, and secondly a clearly smaller event in the hummocky scenery south of Köfels. In how far multiple slope failures can here be backed up by mapping the spatial distribution of ortho- and paragneissic rockslide debris (Fig. 2) and/or different fragmentation patterns, has not yet been solved satisfyingly, but poses a challenging topic for future investigations. However, the radiometric dating data indicate that the failure of the fluvio-glacially steepened Köfels slope was evidently not directly triggered by deglaciation processes, but took a preparation time of some 1.000 yrs after retreat of the late-Pleistocene glaciers. Basically this slope collapse can be attributed to its lithological, structural and morphological predisposition as well as to time-dependent rock strength degrading processes of crack growth, fracture propagation and coalescence of brittle discontinuities.

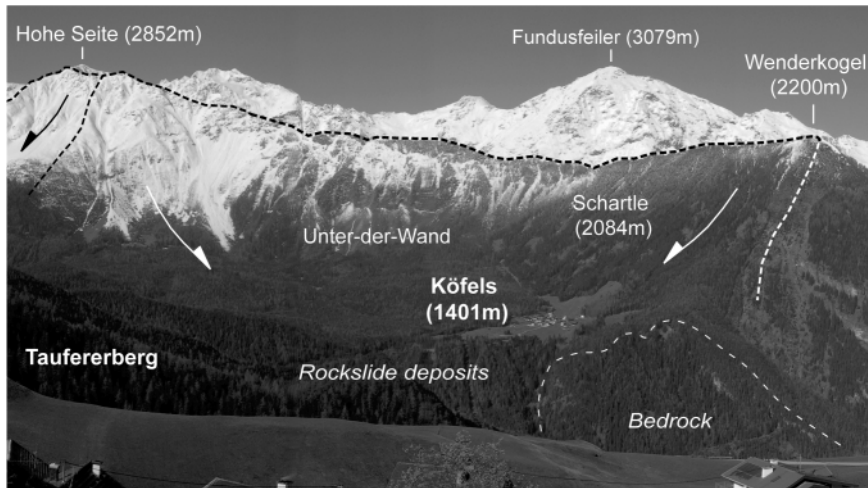
FIGURE 3: Scarp and proximal accumulation area of the rapid Köfels rockslide (view from Höfle/Niederthai towards SW). Indicated are in-situ bedrocks below Köfels, slope collapse between Wenderkogel and Hohe Seite (white arrows) and slowly creeping paragneiss rockslide (black arrow) at the Hohe Seite area (cf. Fig. 2).

The well-exposed head scarp of the Köfels rockslide is characterised by an east-facing amphitheatre-shaped niche (Figs. 1-3). Its western boundary is clearly traceable along the sharp mountain ridge, extending from Wenderkogel along the incision Schartle towards Hohe Seite. The northern scarp flank is morphologically less evident, but situated somewhere in the steep and rugged rock slope northeast of Wenderkogel. The southern boundary of the Köfels niche was previously not clearly defined, but was depicted in a few maps to extend from Pt. 2733 (northeast of Hohe Seite) down slope along a broad east- to northeast-trending ridge (Brückl et al., 2001; Hermanns et al., 2006). This lateral boundary is of major importance for the geological slope model, failure mechanisms

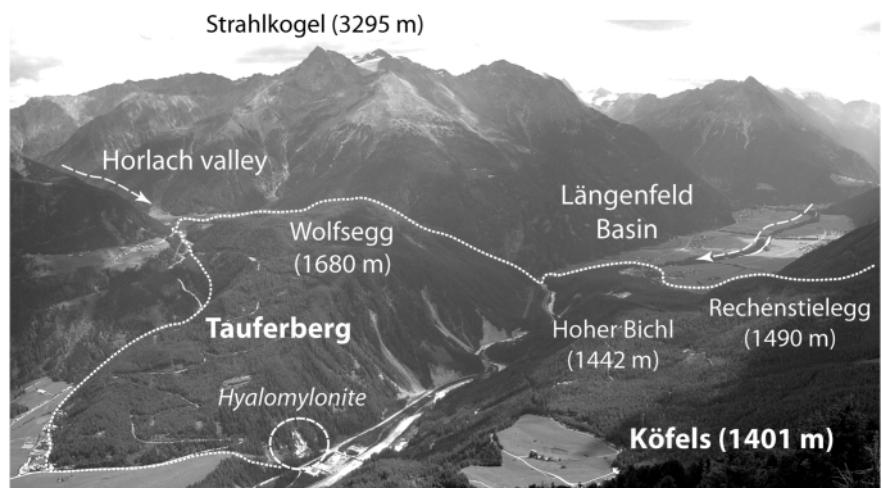
FIGURE 4: Main accumulation area of the Köfels rockslide showing several hundred metres thick deposits and therein incised river Ötz with rockslide-dammed Längenfeld basin in the background.

However, the failing rock masses crossed the Ötz valley, hit their opposite slope and were piled up as a remarkably thick debris ridge, which makes up the Taufererberg (Figs. 1, 2, 4, 9). According to the mechanical model by Erismann et al. (1977) and Erismann and Abele (2001), due to this impact the rockslide mass was separated in to two main units: a lower one, which was blocked by the opposite slope, and an upper one that continued moving further east till Niederthai; in between, a secondary shear zone featuring the well-known frictionites was postulated. So far, the existence of this secondary sliding plane has been subject to dispute but neither been coherently verified nor falsified (Brückl et al., 2001; Hermanns et al., 2006). Rather the rockslide deposits exposed along the deeply incised fluvial canyon Maurach (see Sect. 4) feature relative homogeneous slopes with constant inclinations and do not yield morphological evidence (e.g. slope breaklines, terrain flattening, vegetation changes, spring lines etc.) for the presence of major subhorizontal internal sliding planes, along which intensely disintegrated and/or fused rocks are expected to occur.

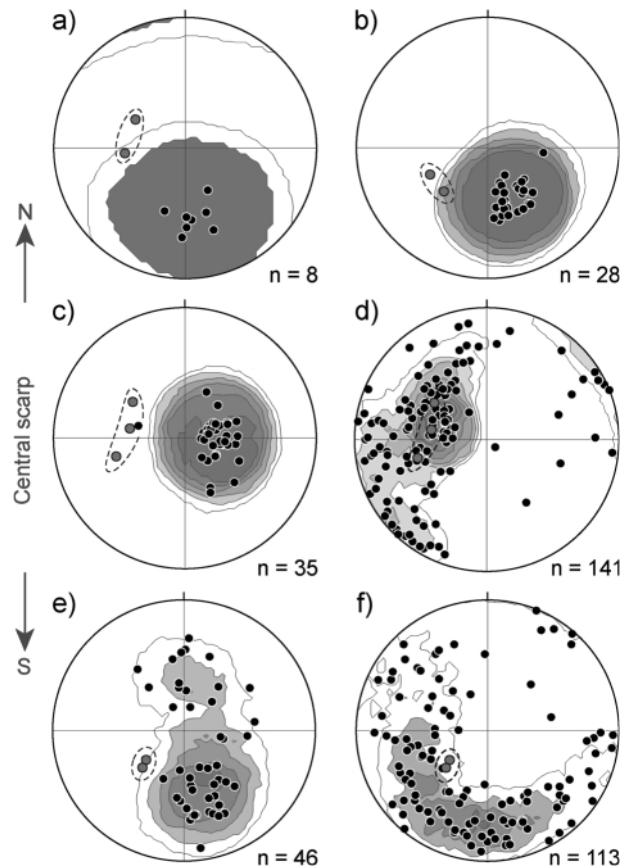
FIGURE 5: Measured discontinuities (black, poles to planes, lower-hemisphere) and mean slope orientation (grey, poles to planes, stippled enveloped) of the Köfels rockslide scarp area: foliation of a) paragneisses in the northern scarp area (Wenderkogel), b) para- and orthogneisses at the slope northeast of Köfels, c) orthogneisses in the central scarp area and e) paragneisses in the southern scarp area (Hohe Seite), as well as fractures of d) orthogneisses in the central scarp area and f) paragneisses in the southern scarp area.

meso-scale tensile joints and shear fractures are encountered in both the ortho- and paragneissic bedrocks. Several discontinuities are coated with chlorite, a few only with quartz. Fault gouges, kakirites or noticeable fault breccias have not been observed so far. The collected field data from the orthogneisses (og) at the SE- to E-dipping slope of the northern and central scarp areas show a scattered spatial distribution (girdle distribution). However, based on overall geological field observations and statistical cluster analyses, four main fracture sets were differentiated (Fig. 5, Tab. 1).

Discontinuity set	Orientation (trend)	Statistical mean	n	Remarks
foliation og (Fig. 5c)	NE-SW to N-S to NW-SE	272/20	35	W-plunging antiform
foliation og/pg (Fig. 5b)	E-W to NE-SW	334/35	28	
og#1 (Fig. 5d)	N-S	97/32	57	major sliding planes
og#2 (Fig. 5d)	N-S	90/76	23	head-scarp deformation
og#3 (Fig. 5d)	NW-SE	47/83	32	orientation Ötz valley
og#4 (Fig. 5d)	NE-SW	152/52	29	
foliation pg (Fig. 5a)	E-W	354/46	8	
foliation pg (Fig. 5e)	E-W	341/42 (and 187/34)	46	W-plunging fold axes
pg#1 (Fig. 5f)	N-S	104/41	31	
pg#2 (Fig. 5f)	E-W	356/61	30	
pg#3 (Fig. 5f)	NW-SE	40/70	27	orientation Ötz valley
pg#4 (Fig. 5f)	NE-SW	300/77	25

TABLE 1: Compiled mean orientations of discontinuities measured in ortho- (og) and paragneisses (pg) at the Köfels slope. Foliation differentiated for areas Scharltle - Unter-der-Wand (Fig. 5c), bedrock slope northeast of Köfels (Fig. 5b), Wenderkogel (Fig. 5a), Hohe Seite - Wurzburg (Fig. 5e). Statistical mean values (azimuth/dip) of foliation and fracture sets based on cluster analyses (Giné statistic; see also Fig. 5).

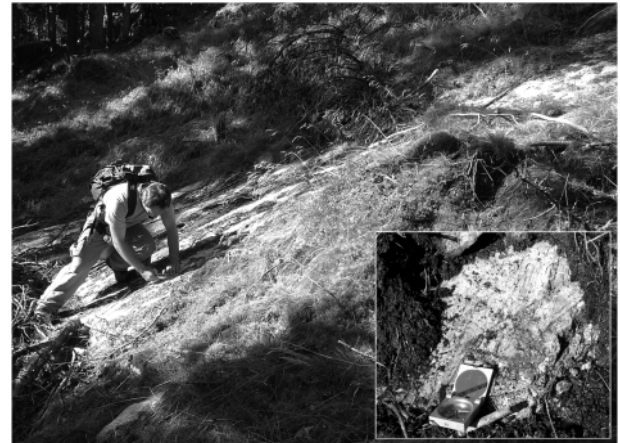
FIGURE 6: In-situ orthogneiss with gently E-dipping (mean azimuth/dip: 100/30), polished major sliding plane of the Köfels rockslide (between Köfels and Scharltle, at approx. 1800 m a.s.l.).

Fracture set og#1 comprises the most striking structural features of the Köfels site, the well-known major sliding planes that are exposed along the path to Scharltle (Figs. 2, 6) and forest roads nearby. Here these rather gently inclined key-fractures, featuring a mean orientation (azimuth/dip) of approx. 100/30 and thus day-lighting sub-parallel to the east-facing slope, show remarkable planar surfaces (Preuss, 1986) and trace lengths of up to several tens of metres. Some of these weakness planes are slickenside coated with quartz, a few exhibiting thin cataclasites (attrition breccias) and others featuring unpolished i.e. rather rough surfaces. Commonly they are devoid of significant striations, but polished and thus showing evidence for shear deformation, most likely of tectonic origin (see Sect. 7) and/or due to the rockslide event. South of the Scharltle - Köfels area, the moderately dipping fractures og#1 obviously decrease in size, density and frequency of occurrence. Other brittle major fault zones of comparable spatial extent, and causing such distinct rock strength anisotropy, are not encountered in the scarp area. Fracture set og#2 comprises steep N-S-striking planes and may be associated with the deeply incised N-trending Fundus valley west of the Köfels scarp (Figs. 1, 2). Central sections of the Köfels head scarp, especially the subvertical rock walls at the location Unter-der-Wand (Fig. 7), exhibit relatively intact orthogneisses that are cut by approx. 60-80° E-dipping main fracture zones. Posing preferred zones of rock weakness, these discontinuities favoured the observed gravitational slope deformations (see Sects. 6, 7). Fracture set og#3, i.e. steeply NW-trending discontinuities, is obviously orientated sub-parallel to the central Ötz valley and corresponds to the present-day stress field, with a maximum principal horizontal stress orientated NNW-SSE (Drimmel, 1980; Heidbach et al., 2008). This and the tempered spring "Bad Längenfeld" (southern Längenfeld basin, cf. Fig. 1), which emanates from a NW-trending joint (Zötl and Goldbrunner, 1993), indicate deep-seated flow systems and according permeable main fracture zones. Fracture set og#4 comprises steeply NE-

(Fig. 10) and several outcrops exhibiting stepped rock surfaces show that ca. 25-35° E-dipping major fractures, which daylight on the E-facing slope and form preferred sliding planes (set og#1; Fig. 6), are cross-linked by ca. 60-80° E-dipping (set og#2) and other discontinuities. The coalescence of this fracture network caused bedrock fragmentation into major slabs and slide blocks, generated persistent failure planes and finally determined the block size distribution of the slide debris. The lateral boundaries of the Köfels rockslide scarp were predisposed primarily by the spatial extent of the orthogneisses and its surrounding E-W-trending paragneisses as well as secondary by NE- and NW-trending fracture sets (og#3-4, pg#3-4), plus random.

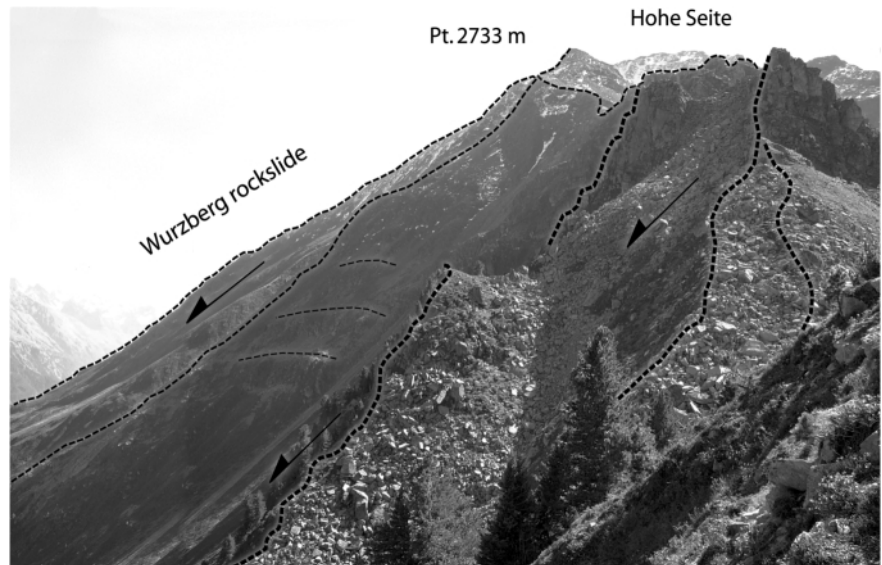
FIGURE 7: Head scarp of the Köfels rockslide (location: top of Unter-der-Wand, approx. 2200 m a.s.l.) showing post-failure deformations of jointed orthogneisses along 60-80° E-dipping main fracture zones. Bedrock disintegration produces coarse blocky talus deposits and causes some minor rock falls. In the background (left skyline) incompetent paragneiss series affected by the slowly creeping Wurzberg rockslide (cf. Figs. 2, 3, 8, 11).

ned (>50° to subvertical) rock walls are cut by several 60-80° E-dipping main fracture zones, which cause E-directed normal faulting of distinct bedrock slabs (Figs. 2, 7, 10). The trace lengths of the individual N-S-trending scarps exceed 500 m, the vertical offsets of the normal-faulted blocks range in the decametre-scale. Evidently the competent orthogneisses deform here along widely i.e. a few decametres spaced main

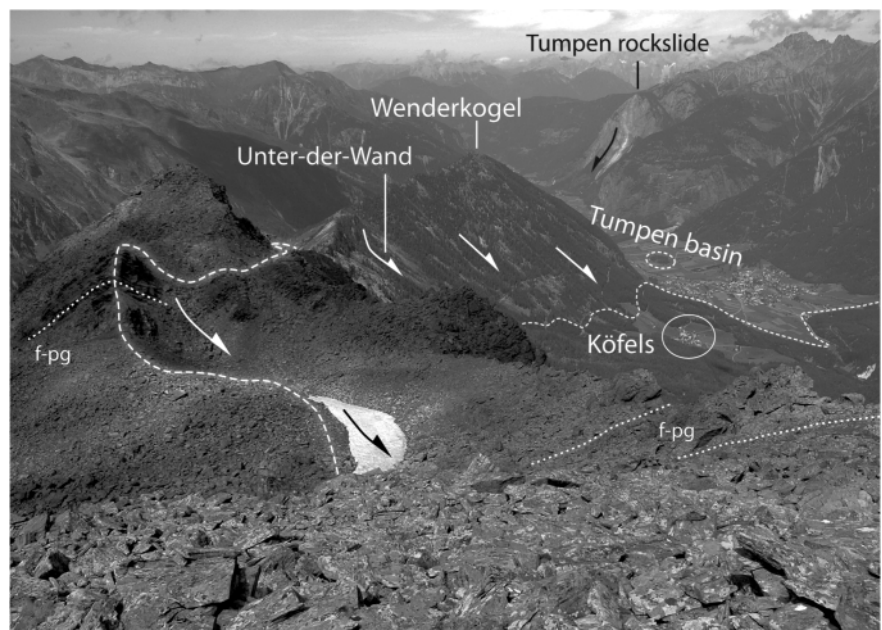
FIGURE 8: Head scarp of the Wurzberg rockslide (near Hohe Seite, view towards North; cf. Figs. 7, 11): fractured paragneiss series (f-pg = trace of foliation; cf. Figs. 5e, f) featuring deep-seated extension zones and NE-facing secondary scarps, with vertical offsets of around a few decametres. Bedrock widely covered by platy talus deposits, with average block sizes being clearly smaller than those of disintegrated orthogneisses (cf. Fig. 7). In the background, orthogneissic scarp and proximal accumulation area of the rapid Köfels rockslide event, as well as isolated rockslide deposits (Toma hill) in the Tumpen basin (Fig. 1).

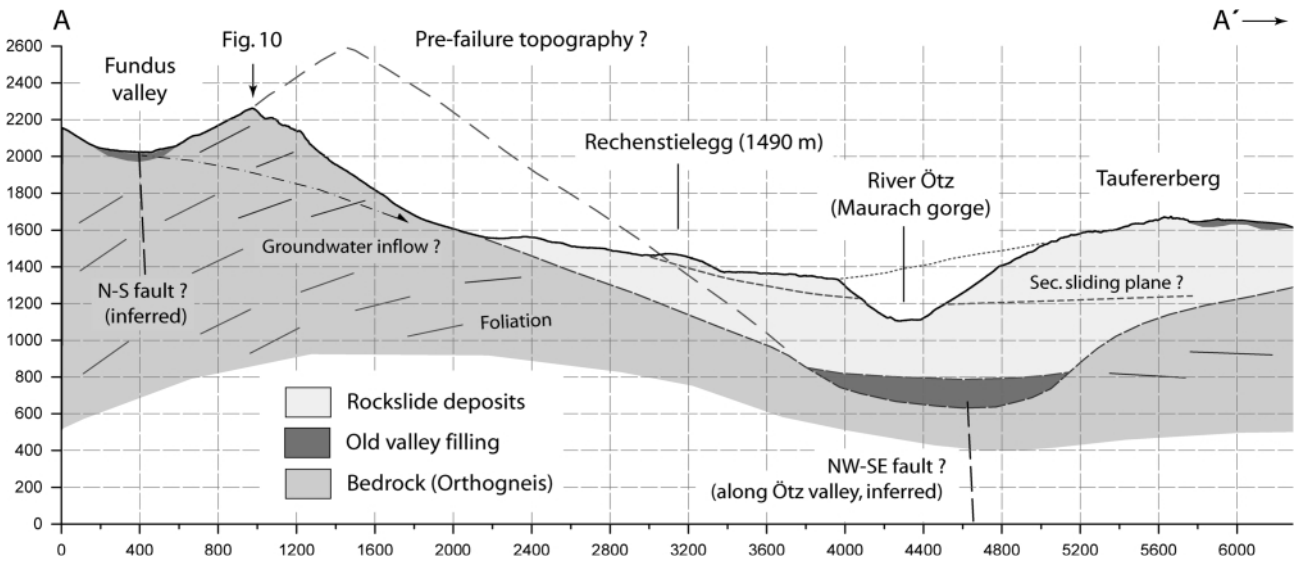
FIGURE 9: Geological cross section of the Köfels rockslide (cf. Fig. 2), with topographic surface line derived from high-resolution airborne laserscanner data (see Sect. 3). Thickness of slide debris according to Brückl et. al. (2001). Potential groundwater inflows (inferred) from the Fundus valley into the fractured bedrock units schematically indicated.

How far the hydrogeological setting, e. g. potential groundwater inflows from the adjacent Fundus valley into the fractured bedrocks in the Köfels area (cf. Fig. 9), contributed to the slope instabilities has not been investigated yet. But the geological field surveys yielded evidence for a close relation between different lithologies, structural setting and slope deformation behaviour. Anisotropic, i.e. structurally controlled, strong rocks, especially at steep slopes featuring high relief energy, generally tend to rapid failure mechanisms such as rock collapses and catastrophic rock slides (Hungr and Evans,

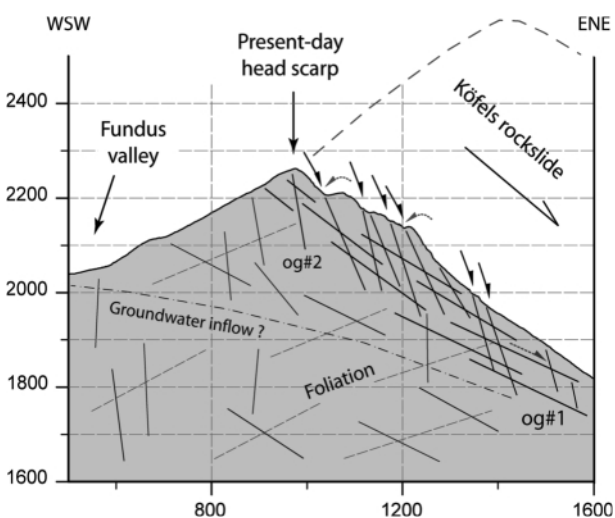
FIGURE 10: Stepped slope profile encountered in competent orthogneisses (location: Unter-der-Wand), indicating post-failure scarp deformation along en-echelon arranged steep fractures (set og#2; cf. Figs. 5, 7, 11) (i.e. zoom-in of Fig. 9, horizontal scaling according to Fig. 9).

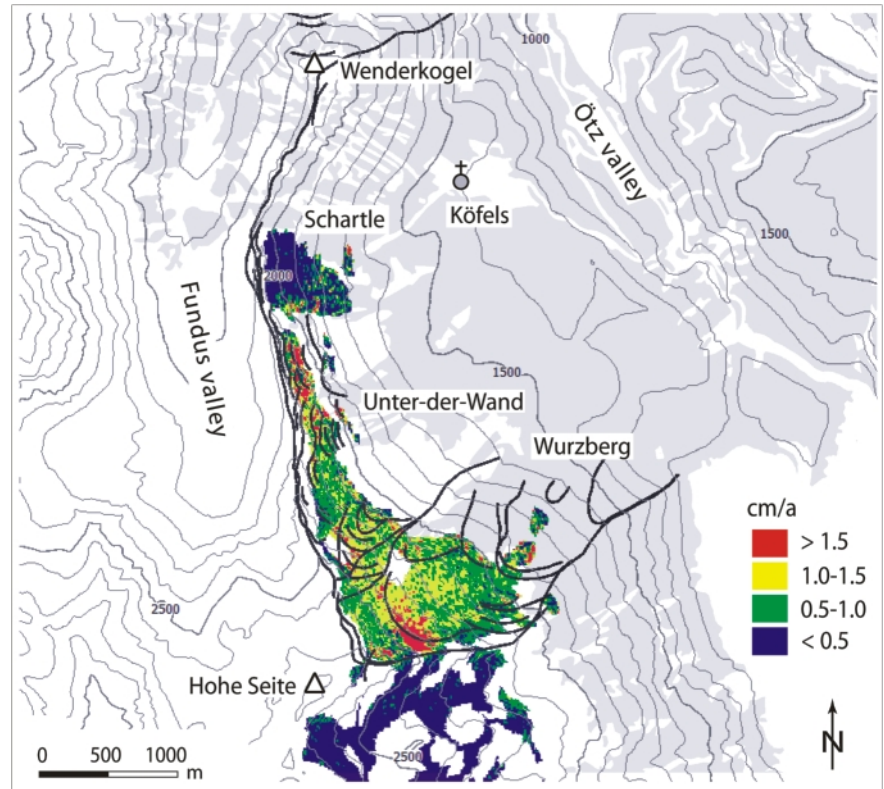
FIGURE 11: InSAR based motion field (surface parallel assumption) derived from ENVISAT ASAR images (acquired on 7 August 2004 and 27 August 2005) showing active rockslides in the Wurzburg and Unter-der-Wand areas. Scarps (black lines) according to field surveys (Fig. 2). At lower slope sections radar signal decorrelations due to dense vegetation (grey; depicted according to Austrian Map ÖK).

slope instabilities have been cross-checked with recent analyses of repeat pass satellite-borne radar (InSAR) images. The available InSAR motion field (Fig. 11) is based on the ASAR image pair 7 August 2004 and 27 August 2005. A Digital Elevation Model with 10 m pixel spacing was used for removing the interferometric phase contributions due to topography. Inaccuracies of the DEM can be neglected as the imaging geometry of the image pair has a low sensitivity to elevation, e.g. one interferometric phase cycle of 2π corresponds to an elevation change of 623 m (height of ambiguity). Another error source might be different atmospheric conditions, especially tropospheric water vapour content, at the time of the two image acquisitions. These effects cannot be removed from a single image pair, but are in general at scales larger than several kilometres or tens of kilometres.

The InSAR based motion analyses show a typical displacement rate of 0.5 to 1.5 cm/a (surface parallel assumption) in the Wurzburg area and in the upper part of Unter-der-Wand. The area below Schartle shows no displacement in the main part, and low displacement rates (< 1 cm/a) in the lower part. At lower sections of the slope (below ca 1800 m) dense vegetation, mainly shrubs and forests, are present, which cause temporal decorrelation of radar signal of the two images permitting the retrieval of motion information (masked in Fig. 11). The size and spatial extent of the motion field indicates, in cross-check with geological field surveys and optical images, that the terrain displacements clearly affect larger bedrock areas. For this study, only one SAR image pair with 1 year time interval was available. The analysis of further SAR image pairs with different time intervals (several months to 2 years) will improve the reliability of the InSAR based motion field, especially when combined with geodetic measurement campaigns, and enables to study the annual velocity variations of the observed rockslides.
