| Mitt. naturwiss. Ver. Steiermark | Band 132 | S. 43–62 | Graz 2002 |

The influence of landuse on the stability of slopes with examples from the European Alps

Von Andreas KELLERER-PIRKLBAUER¹

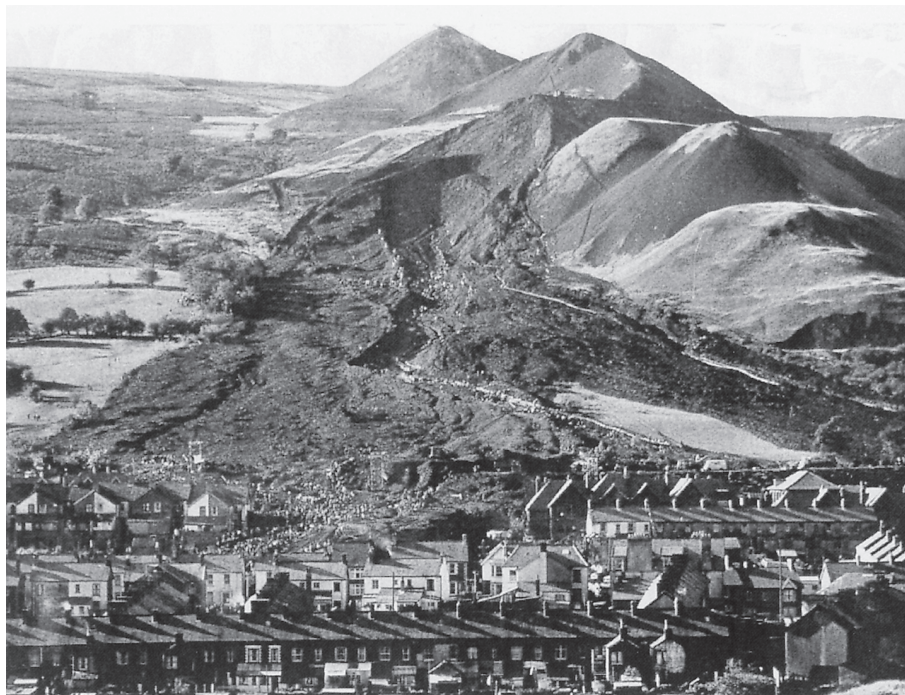
Fig. 1: Photograph to show the extent of the 1966 Aberfan landslide (JOHNES & McLEAN 1999).

Aberfan is a small town in Wales, situated in a coal mining area of the Welsh mountains. In this coal mining region, heaps of excavated debris from the coal mine were being piled on a hillside above the town. The spoil heaps or tips had been there for more than 20 years on top of the local Brithdir Sandstone, a highly porous rock layer. The sandstone contains many springs and several of the tips were placed above these springs. This had led to destabilization of some of the tips in 1944 and 1963 with the result of minor landslides. But at 9:15 a.m. on the 21st October 1966 on one of the seven artificial tips a huge slope failure occurred. About 160,000 m³ of coal mining waste slumped abruptly on the valley sides and flowed downhill at high speed. The front part of the debris became liquefied and moved as a series of viscous surges down slope. Approximately 120,000 m³ of debris were deposited on the lower slopes of the mountain and about 40,000 m³ came to rest in the urban area of Aberfan (Fig. 1). The landslide destroyed part of the town and killed 144 people (ALEXANDER 1993).

The tip consisted of mine waste debris in different grain sizes. High annual rainfalls, the disturbance of the natural drainage system, unstable slopes and the presence of fine grained so called "tailings" caused the failure in Aberfan (BOLT & al. 1975, WALTHAM

1978). In the case of Aberfan it was not a natural slope which failed, but a human built hill which suffered slope failure.

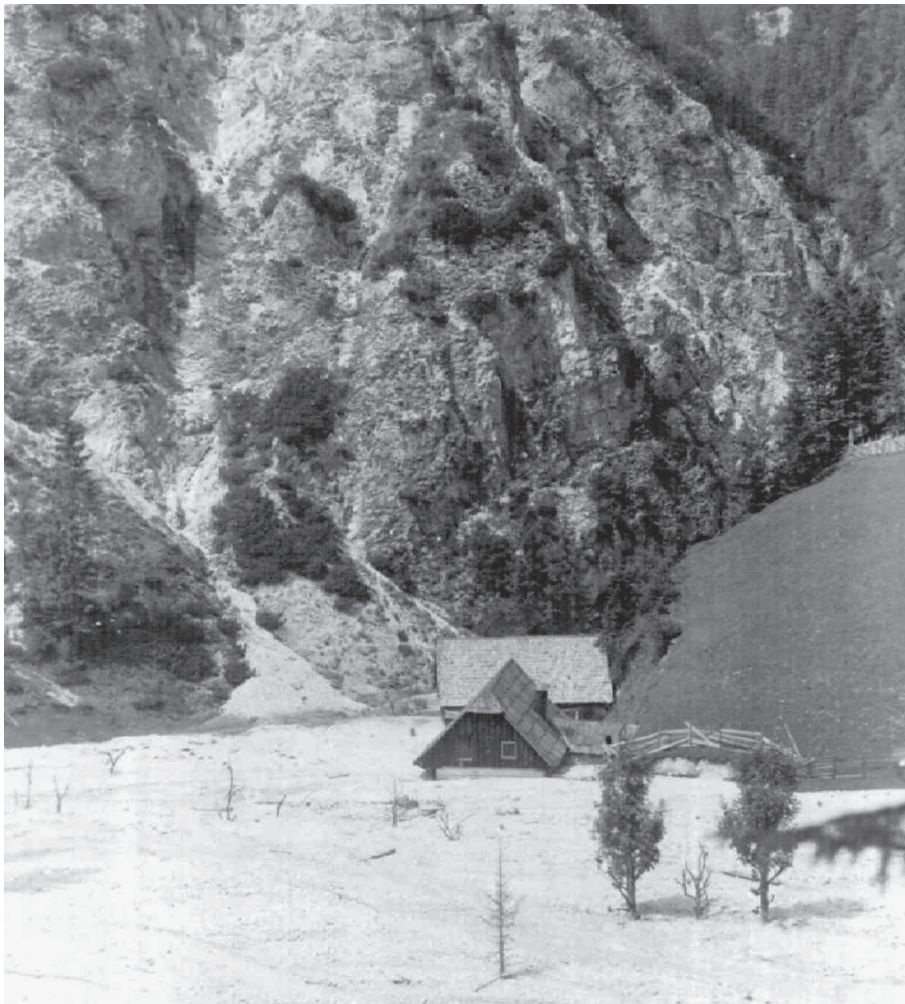
Fig. 3: Debris filled valley bottom of the Holzaepfel Valley around 1950. Note the partly buried buildings and the almost unvegetated steep slopes with debris cones in the background (by courtesy of WLV, Vienna, Austria).

Transported material from higher areas of the drainage catchment covered the agricultural land at the valley bottom with a thick layer of debris. Figure 3 shows the situation at the valley floor and the neighbouring hillside around 1950. Debris from the adjacent slopes and the side valley deposited on the valley floor, thereby destroying a farmhouse and the agricultural land around it. Clearly visible in the same figure are the almost unvegetated steep slopes behind the buildings. Today, a broad braided river is covering the whole width of the valley floor in some sections. No agricultural use of the valley floor is possible and most adjacent slopes are again covered with mature forest (Fig. 4). Yet, many slopes with till material depots, especially in the valley bottoms of small side

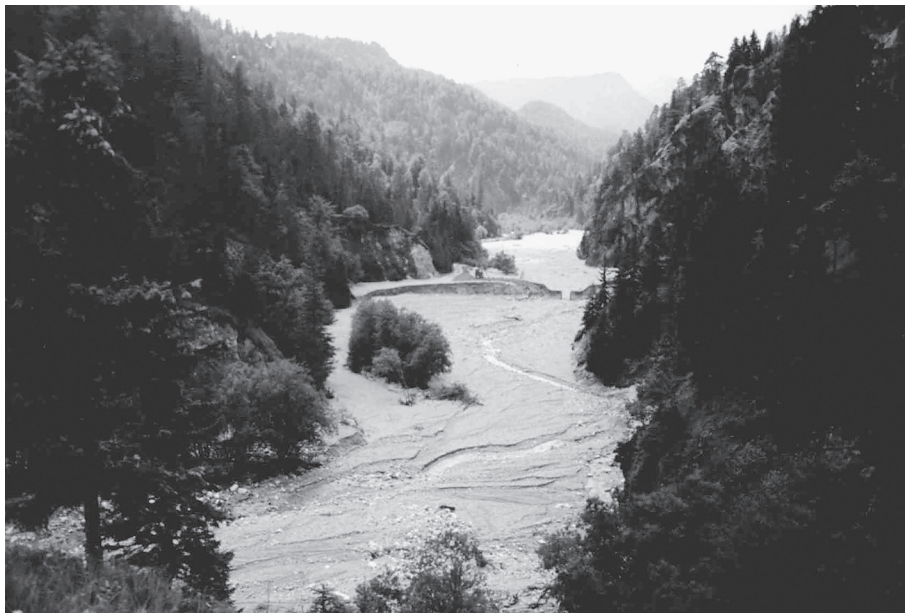
Fig. 4: The situation of the Holzaepfel Valley in 1998. The whole valley floor is covered with debris. The adjacent slopes are covered with mature mixed forest. (by courtesy of Herwig PROSKE, Joanneum Research, Graz, Austria).

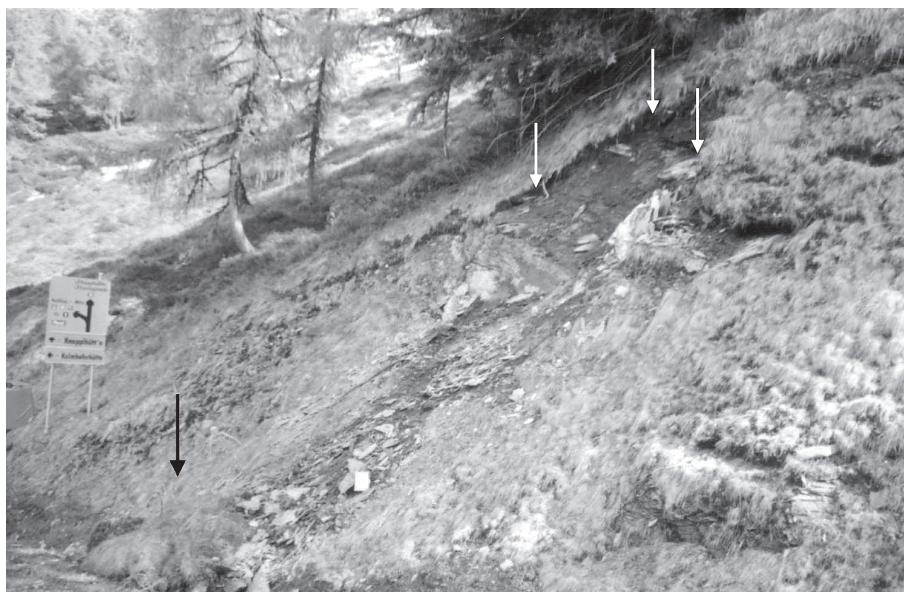
Fig. 5: A shallow translational slide on the upslope edge of a human-modified ski-run in the Hauser Kaibling ski-area. Note the ~20 cm long field book for scale in the centre. The white arrows indicate the area of release. The underlying bedrock material (schist) is visible. The black arrow indicates the landslide deposits (KELLERER-PIRKLBAUER 2001).

The main reason for destabilisation at the study area are changes of the natural topography due to digging off and relocating of slope material during the construction of ski-lift and ski-run infrastructure. But also the building of supply-roads for the skiing infrastructure caused slope instabilities. Further reasons for altered stress conditions on slopes are changes in the hydrological system (altered groundwater flow, higher surface runoff), in the pedological system (destruction of soil structure due to heavy machinery) and the vegetation system (destruction of forest and closed vegetation cover) (KELLERER-PIRKLBAUER 2001).

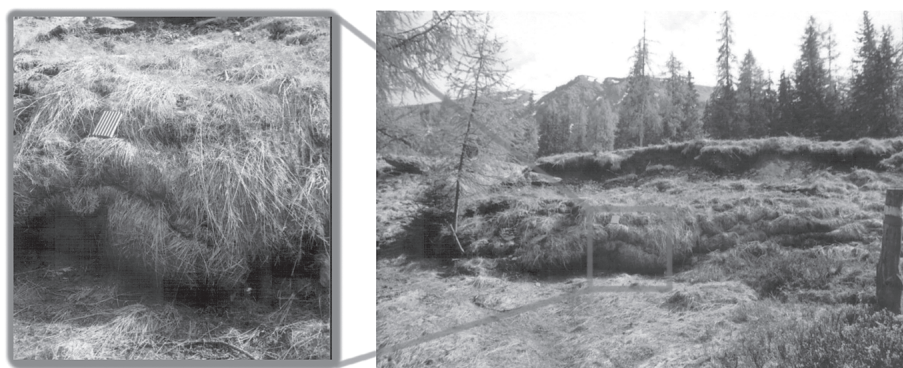
Fig. 6: A rotational landslide on the topographical lower margin of a human-modified ski-run in the Hauser Kaibling ski-area. Field book for scale (20×12cm). The landslide mainly consists of fine material. Remarkable is the roll-in structure of the head of the moved mass (KELLERER-PIRKLBAUER 2001).

The second example is shown in figure 6: In this case a short but broad slump or rotational landslide occurred on the topographical lower margin of a human-modified ski-run. This ground failure was mainly caused due to high water pore pressure from meltwater. Because the artificial margin of the ski-run was just about 2 m higher than the natural margin and the gentle slope below the ski-run, the probably slow moving mass stopped already at the bottom of the short ski-run slope.

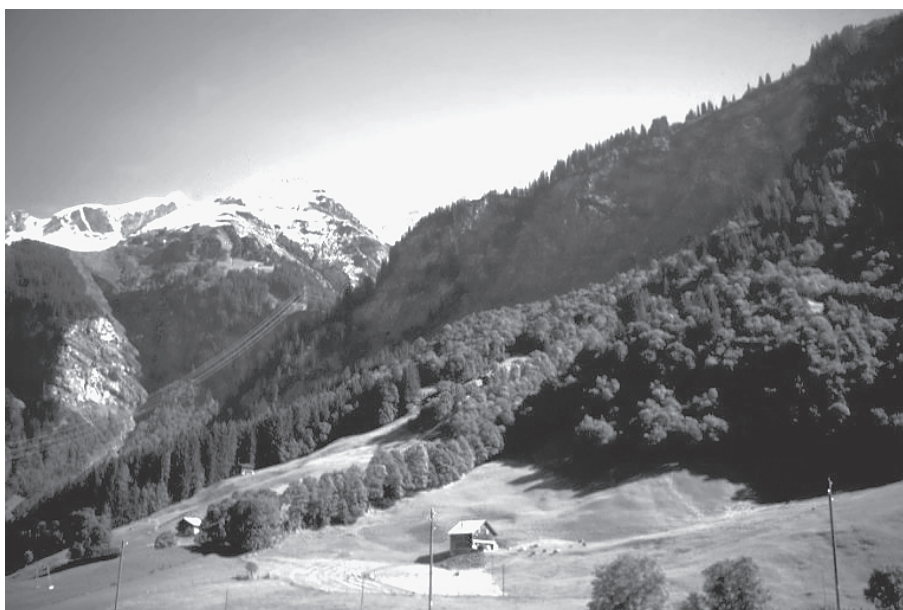
Fig. 8: The forest and meadow covered debris cone on the foot of the Plattenberg of the 1881 rockfall in Elm, Switzerland (SWISSFOT).

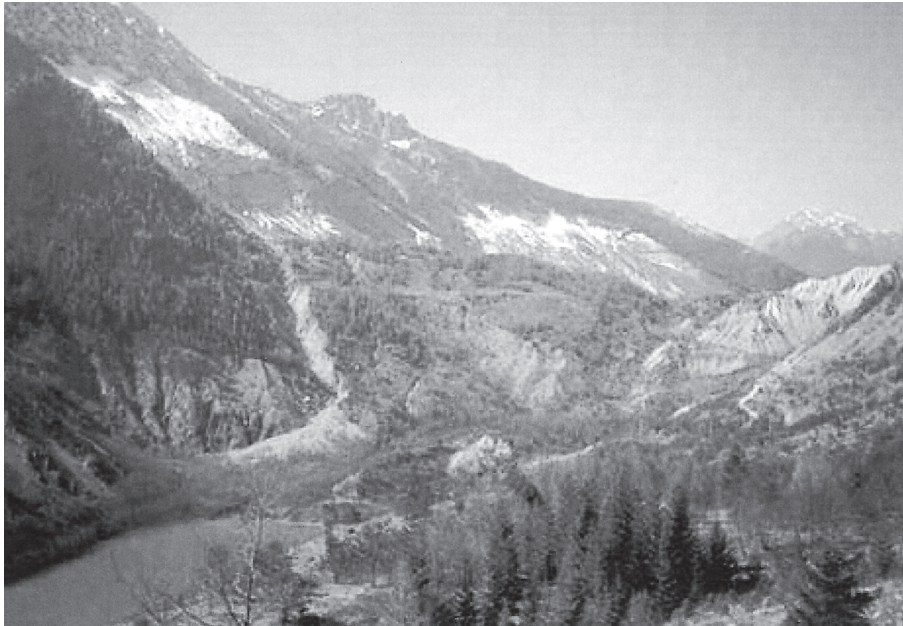
Fig. 11: The Vaiont landslide: Note the rock mass in the centre of the valley, the area of release (covered partly in snow) and the transition zone to the left and the residual lake at the left bottom corner of the photo. View of the landslide from upstream to West (BROMHEAD 2000).

Catastrophic failure: At 10:38 p.m. on October 9th, 1963 catastrophic failure of the 1.8 km long and 1.6 km wide landslide occurred. This tremendous mass on the northern slope of Monte Toc, consisting of an estimated 240 million m³ or 0,24 km³ (LONGWELL & al. 1969), slid approximately 500 m northwards at up to 30 m per sec. This movement was setting even seismic waves that were recorded throughout much of Europe.

Within about 1 minute, debris had filled the reservoir and had piled up to more than 150 m higher than the water surface. The mass completely blocked the gorge to a depth of up to 400 m (Fig. 11). At the time the reservoir contained 115 million m³ of water. Air compressed by the rapidly flowing debris, water and rock masses moved up the opposite wall of the reservoir where it destroyed the village of Casso, 260 m above the former lake level, before spilling over the dam by approximately 100 m. The water, estimated to have had a volume of about 30 million m³, then rushed down to Val Serpentine, where it almost completely destroyed the large village of Longarone (Fig. 9). The smaller rural villages of Pirago, Villanova, Rivalta and Fae were totally destroyed. In total about 2500 lives were lost. All of this occurred in about seven minutes. The disaster came too fast to allow the slightest chance of escape. Remarkably the dam remained
