THE DEVELOPMENT AND PROBLEMS IN THE  
ANTI-EROSION PLANTATION IN JAPAN

Hidehiro Ishibashi  
Professor of Forestry  
Department of Forestry, Faculty of Agriculture  
Iwate University  
Ueda 3, 020 MORIOKA, Japan

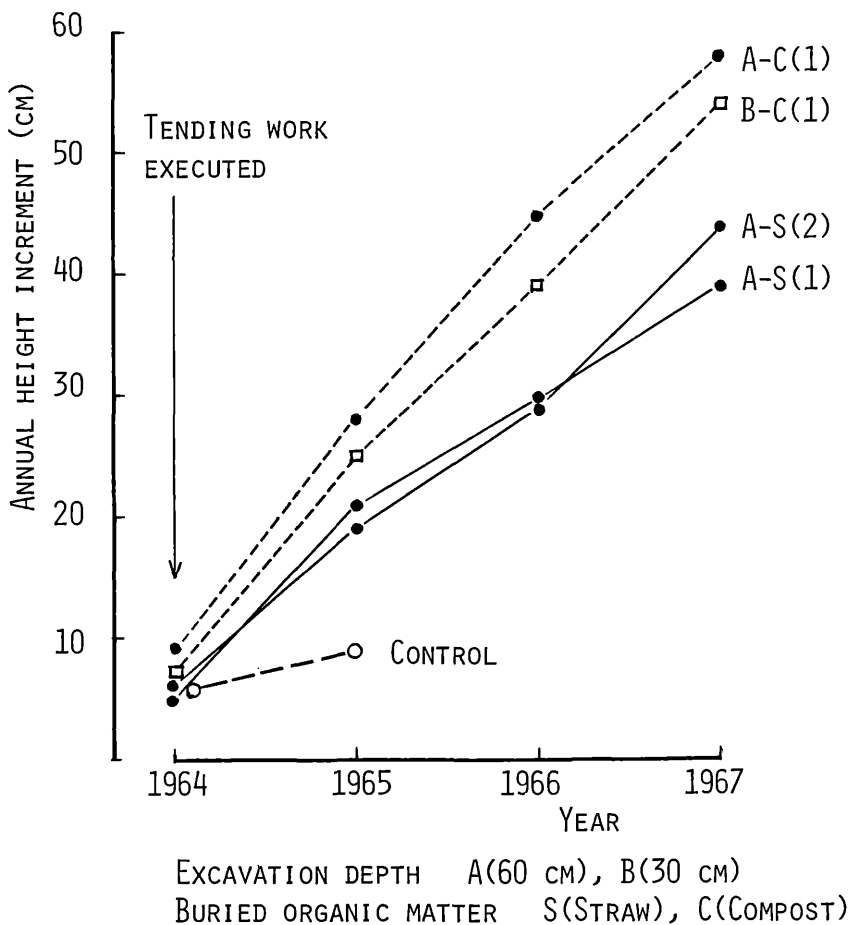
Increase in the tree height growth stimulated by The Tending Work was found in the whole plot. Some typical instances are shown in Fig.10.

Fig.10 Increase of annual height growth of *Pinus Thunbergii* resulted from the Tending Work B in TANAKAMI Area.

Drawn from the data by TSUTSUMI (5).

TSUTSUMI(5) had determined an average annual height growth of the declining pine trees in the sampled plots composed of two degrees of excavation depth (60 and 30cm), two kinds of buried organic material (rice straw and compost), and four kinds of fertilization amount.

One year after the execution of The Tending Work the trees scarcely attained greater height growth in the whole plot. It took about three years before the treated trees attained a distinctively greater height increment than the control ones whose annual height increments are less than 10cm.

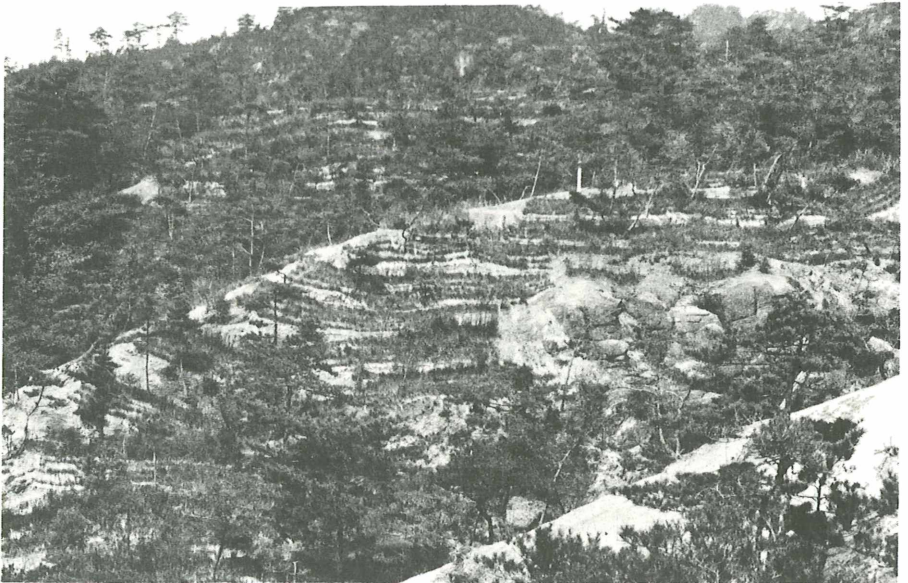
Fig.12 Just after execution of the anti-erosion plantation.

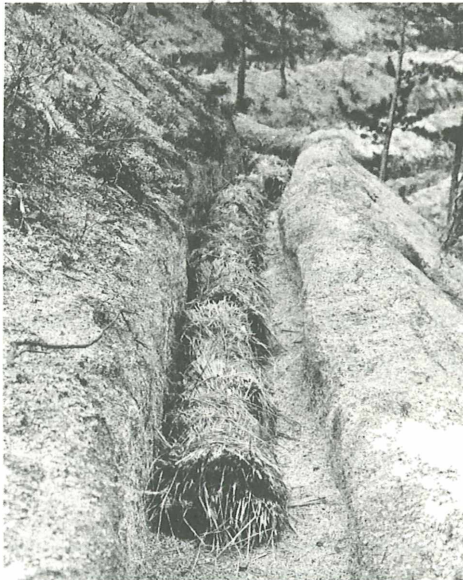
Fig.14 Under execution of the Tending Work B in the declining forest. Straw is put into the excavated trench.
