Fluvial processes and changes in the floodplain vegetation of the Vjosa river (Albania)

Nils RÖSSLER, Gregory EGGER & Anton DRESCHER

RÖSSLER N., EGGER G. & DRESCHER A., 2018: Flussmorphologische Dynamik und Vegetation im Inundationsgebiet der Vjosa (Albanien).

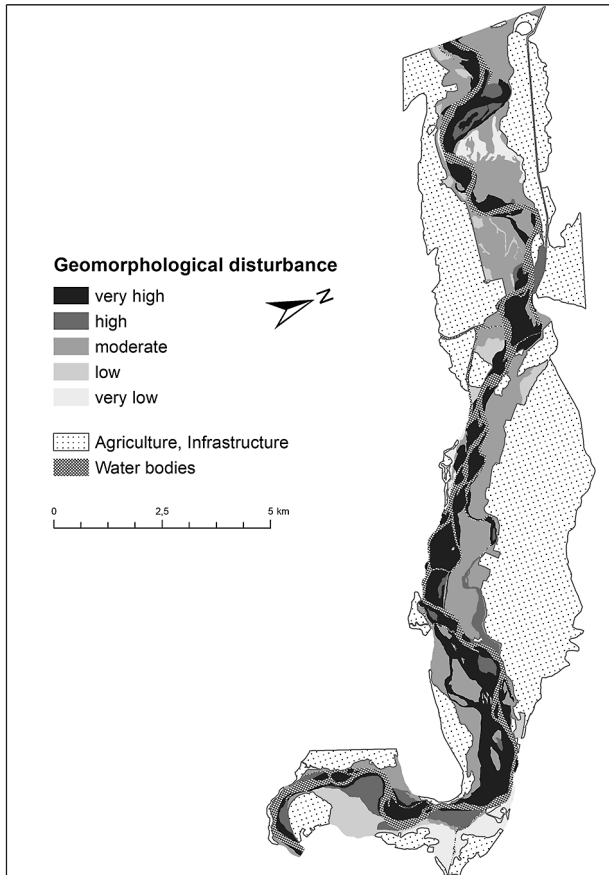
Fig. 3: Geomorphodynamic disturbance along the Albanian Vjosa River (modified from RÖSSLER 2017). – Abb. 3: Verteilung der Flächen gleicher geomorphodynamischer Störungsklassen im Kartierungsgebiet der Vjosa (modifiziert nach RÖSSLER 2017).

More than half of all mapped vegetation types related to the reviewed floodplains were characterized by their high to very high geomorphodynamic disturbance (very high 46 %, high 13 %). Almost one third was covered by moderate disturbance, where a thin layer of litter and humus was detected. The remaining vegetation types are characterized by mor-

phodynamics that have already been interrupted for a long time, leading to an advanced stage of soil evolution (class low and very low each 5 %) (Fig. 3).

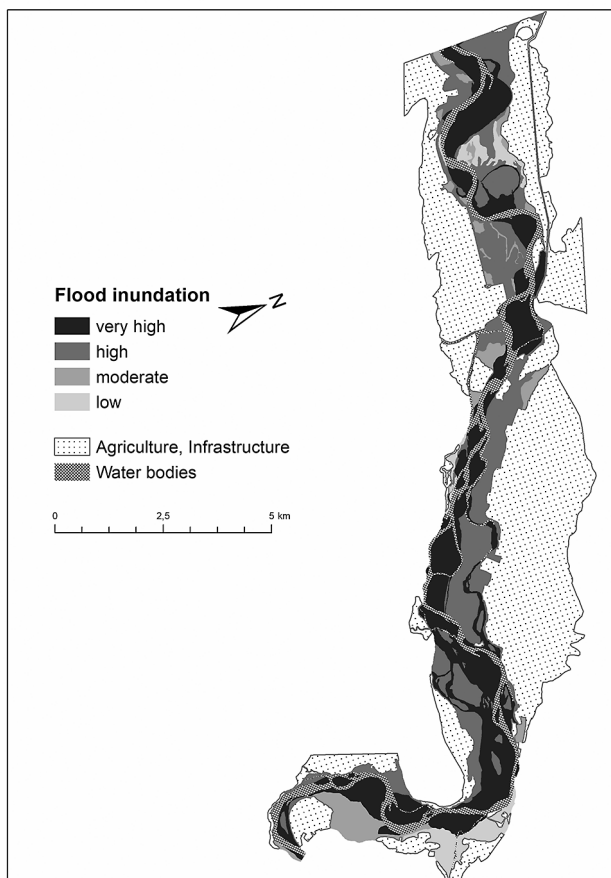
Fig. 4: Flood inundation of the study site (modified from RÖSSLER 2017). – Abb. 4: Verteilung der Flächen gleicher Überflutungshäufigkeit und -intensität im Kartierungsgebiet der Vjosa (modifiziert nach RÖSSLER 2017).

Mostly, flood inundation of gravel banks, pioneer vegetation and Oriental plane pioneer shrubs was very high. All other vegetation types were also characterized by mostly high and moderate flooding impact, whereas the forests predominantly showed minimal flooding impact (Fig. 4).

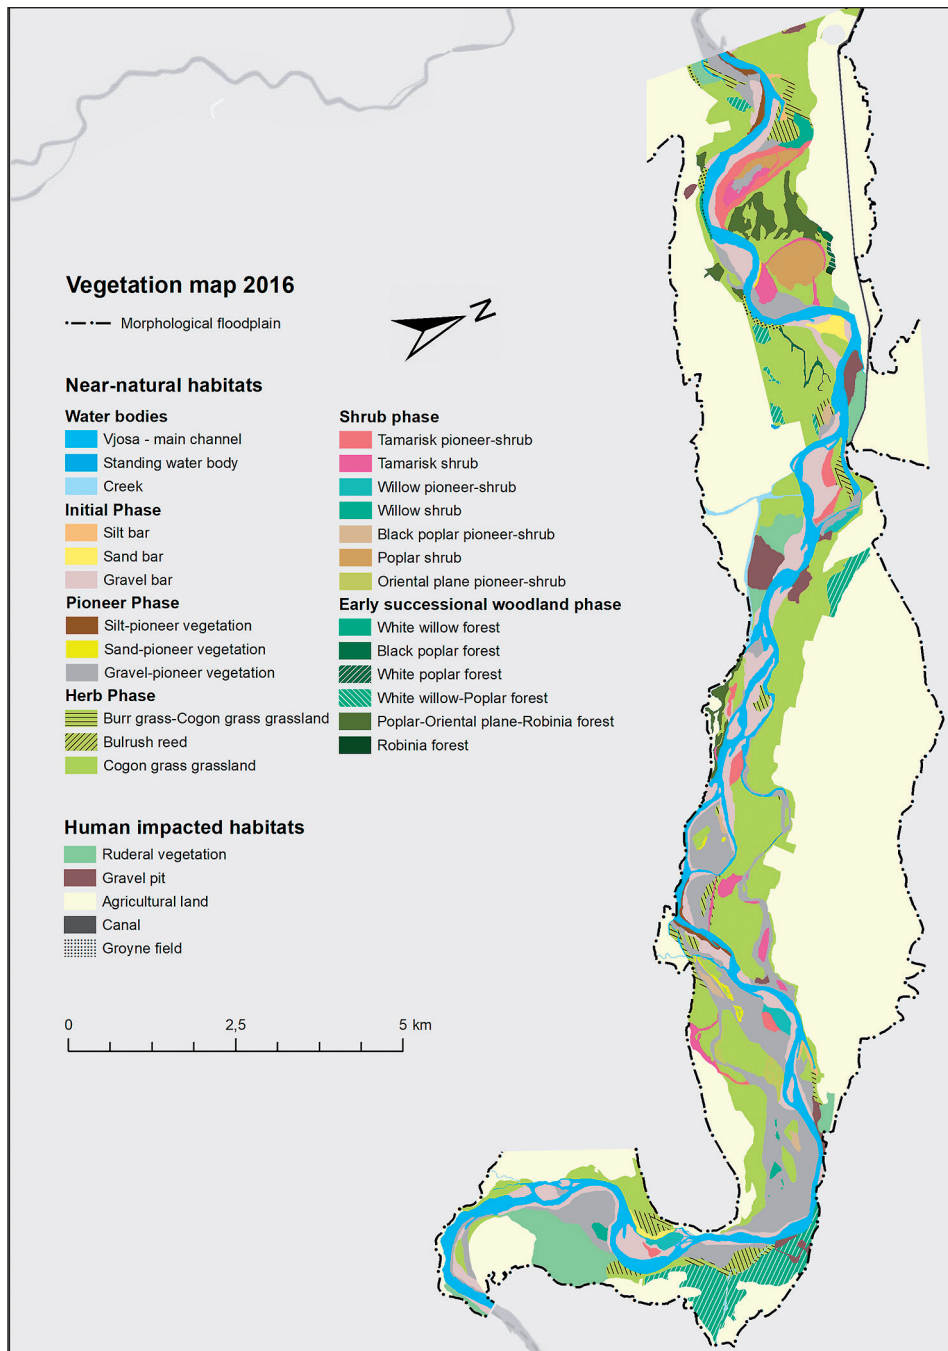
Fig. 5: Map of current vegetation (modified from RÖSSLER 2017). – Abb. 5: Karte der realen Vegetation des Untersuchungsgebietes (modifiziert nach RÖSSLER 2017).

vegetation (265 ha, 19 %) along both the main stream and the repetitively shifting anabranches (Fig. 5). Within these pioneer stages dominated by herbs and shrubs, typical woody species are white, purple and rosemary willow (*Salix alba*, *S. amplexicaulis*, *Salix eleagnos*), smallflower tamarisk (*Tamarix parviflora*), white and black poplar (*Populus alba*, *P. nigra*) and oriental plane (*Platanus orientalis*). These woody pioneer species stabilize the substrate and lead to a further sedimentation of fine grained sediments. This leads to a more or less dense bushland on stands without extremely high morphodynamics (height 1 to 3 m). This pioneer bushland occurs with changing species composition and alternating dominance and cover, both as a mixed inventory and as a mosaic with alternating dominance conditions, and covers approx. 10 % (140 ha) of all near-natural plains.

Slightly more than half (1644 ha) of the almost 32 km² of comprehensively mapped reference section of the morphological floodplain are covered by agricultural fields and grasslands (Fig. 5). They are located on a higher floodplain level and are accompanied by near-natural plains crucially affected by floods in central parts of the floodplain area. They are characterized by broad and annually repetitively shifted topographic surfaces of non-vegetated gravel bars (171 ha, 12 % of near-natural banks) and pioneer

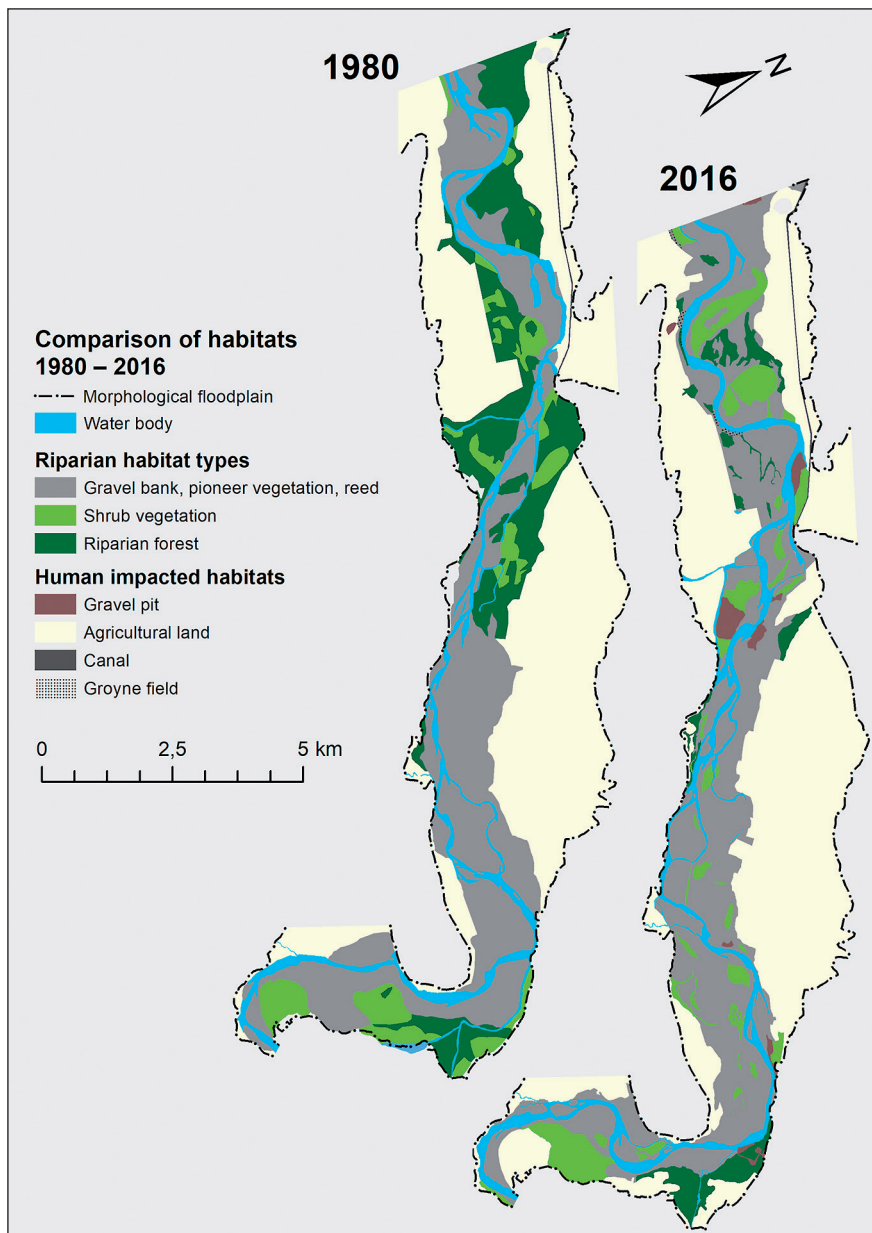
Fig. 6: Habitat maps from 1980 (Original map source: Mapbasis: People's Socialist Republic of Albania, State system of coordinates; KESH & SOGREAH CONSULTANTS 2008) and 2016 (modified from RÖSSLER 2017). – Abb. 6: Habitat Karten von 1980 (Original: Volksrepublik Albanien, Staatliches Koordinatensystem; KESH & SOGREAH CONSULTANTS 2008) und 2016 (modifiziert nach RÖSSLER 2017).

within the morphologic floodplain shows an increase of approx. 176 ha or 12 % (from 1468 ha to 1644 ha) regarding areas used intensively for agriculture (Fig. 5). Also, areas of open gravel bars, pioneer vegetation and herbs increased by approx. 130 ha or 13 % (from 970 ha to 1100 ha). In contrast, bushland decreased by nearly 70 ha or 30 % (from 211 ha to 140 ha). Floodplain forests show the most obvious loss of area. Here, within the last 35 years, a reduction of 354 ha took place – that equals almost one quarter of the original area in 1980 (from 491 ha to 137 ha). The detailed analysis shows that the lost forest area was intermediately grubbed up and transformed into both crops and grasslands for intensive agricultural use (104 ha) or into cogon grass meadows for extensive grazing (180 ha) (RÖSSLER 2017).

The Vjosa stream course has probably been relocated within the active channel, and former side channels are now desiccated and new ones have been formed. However, the total area of water bodies has remained roughly the same. This indicates that processes of river

bed forming did not change over a longer period and is also an indicator of, as yet, sparsely changed morphodynamics (Fig. 6).
