Sediment related environmental problems at the Lower Danube

Stefan Modev & Silvia Kirilova

Zeitschrift/Journal: Umwelt - Schriftenreihe für Ökologie und Ethologie

Artikel/Article: Sediment related environmental problems at the Lower Danube. 73-89

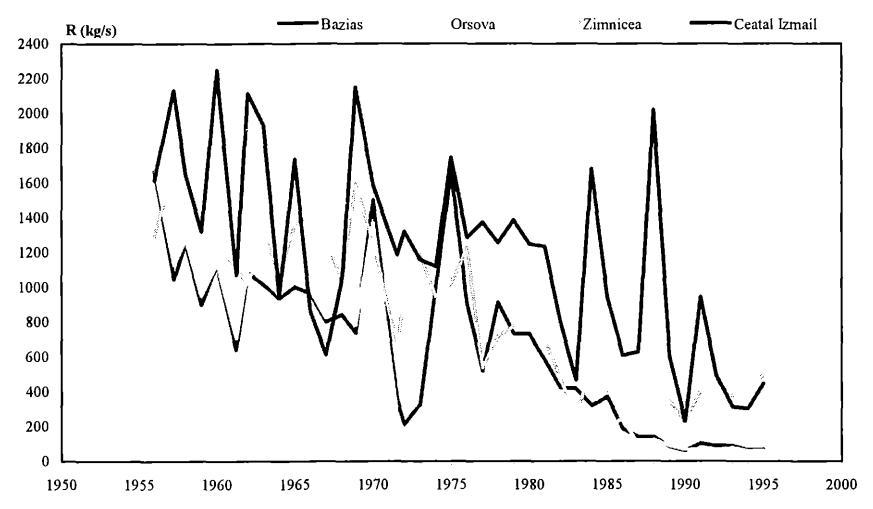
Fig. 1. Suspended sediment load hydrographs of the Danube river (Romanian stations) (Source: Morphological Changes and Abatement ..., Gutknecht, Modev, Bondar, 2000)

The main suspended load time series on the Danube river from Romania and Bulgaria are shown in Figs. 1 and 2. In Fig. 3, the contribution of the Danube river and the tributaries to the suspended load total input to the downstream section is shown. It is important to note that the tributaries contribution is, roughly assessed, around the half of the total. All inputs, during the considered time, decreased approximately at the same rate. For 1983–1995 this results, finally, in almost the same relative input rates, but at a considerable lower rate.

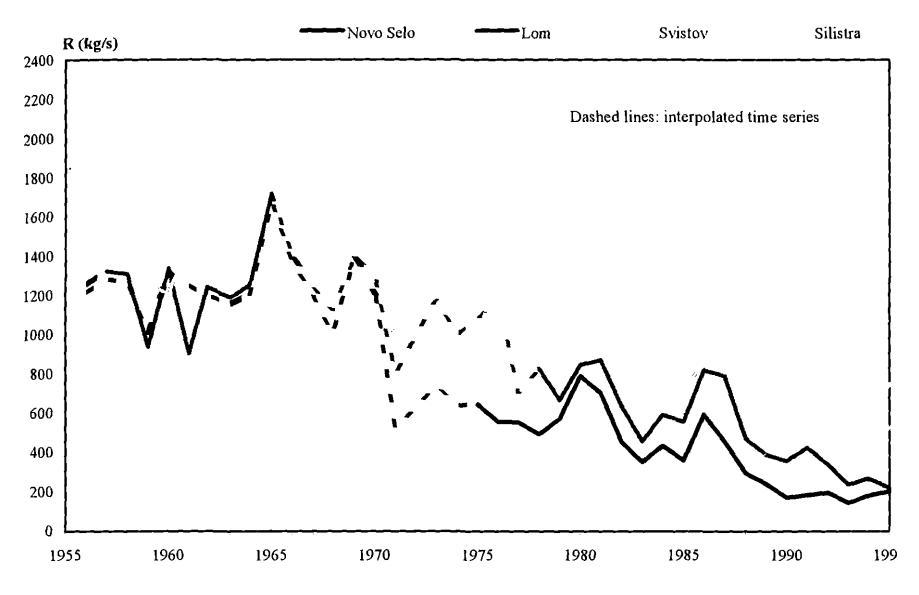
Fig. 2. Suspended sediment load hydrographs of the Danube river (Bulgarian stations) (Source: Morphological Changes and Abatement ..., Gutknecht, Modev, Bondar, 2000)

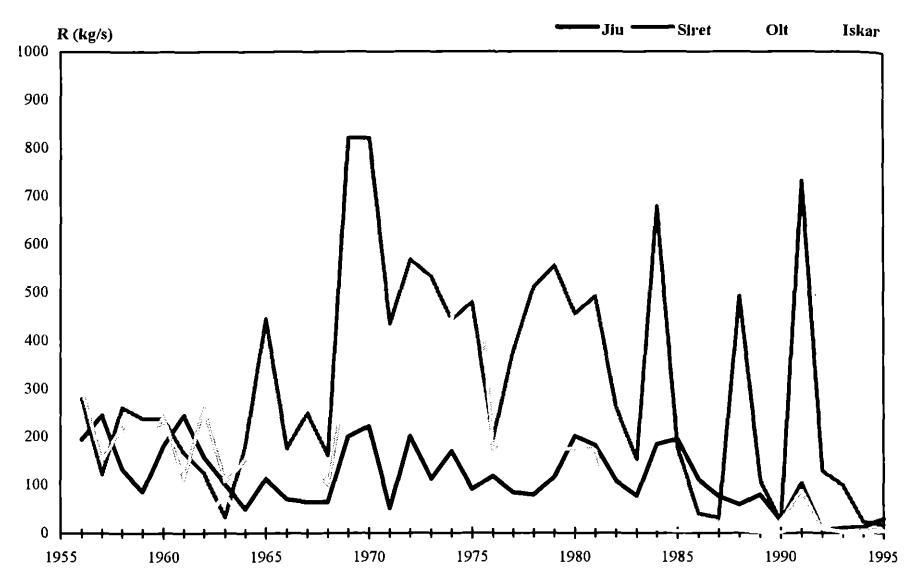
Fig. 3. Suspended sediment load hydrographs of the main downstream Danube river tributaries

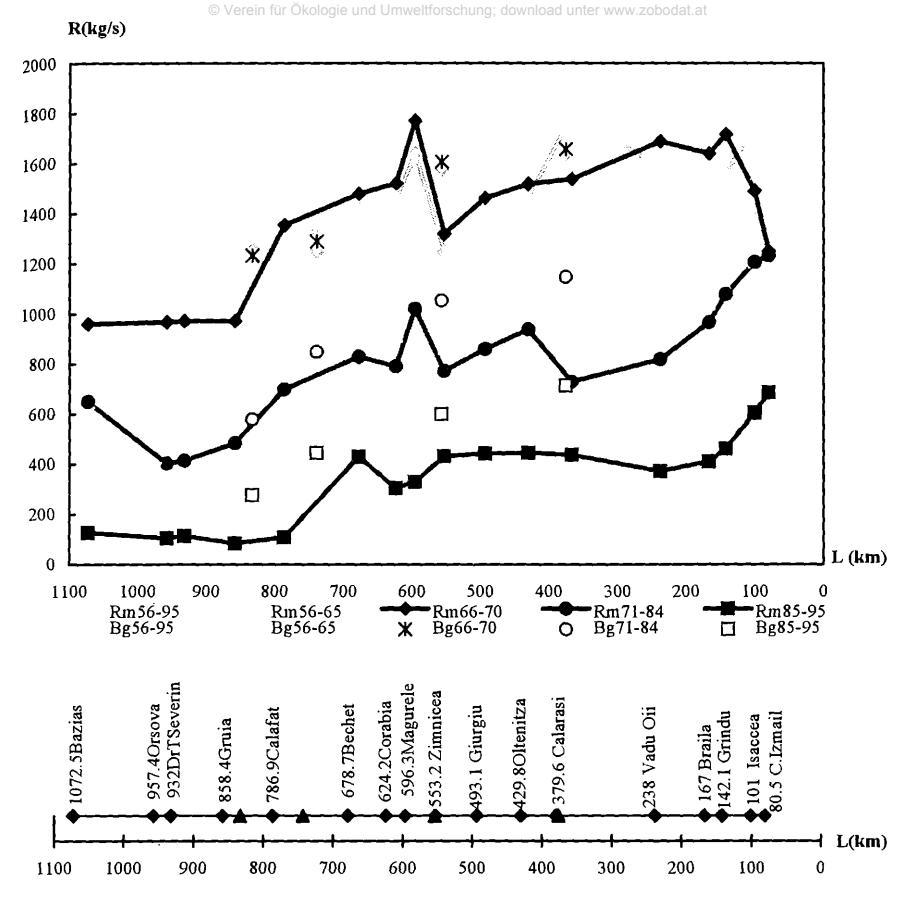
Fig. 4. Suspended sediment load along the Danube river for different time periods (Rm-Romanian data; Bg-Bulgarian data)

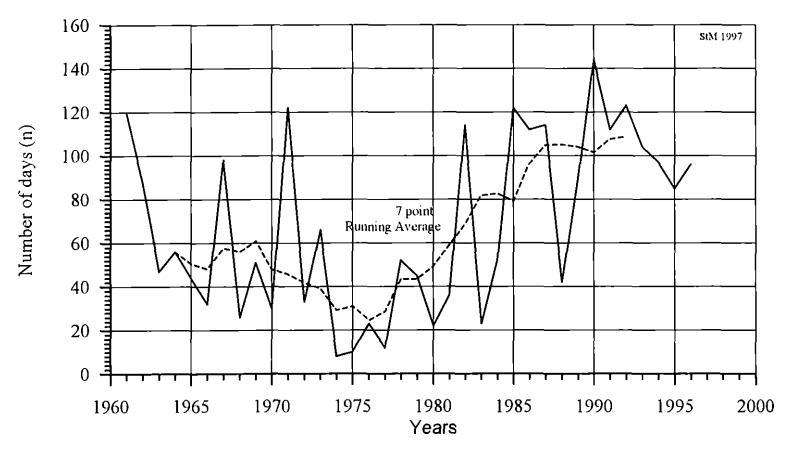
Fig. 5. Change of the annual number of days (n) with affected navigation conditions for the Danube river (common Bulgarian – Romanian Section).

Maintenance and management of the navigation. It depends from the crossings (bottlenecks) regime and space dimensions of the riverbed. The development of the negative impacts is well seen on fig. 5.

The navigation conditions are of grate importance for the development of the riparion regions. During the last 30 Years the navigational conditions goes and stay heavier. The intensive morphological process reflect mainly on the bottlenecks regime. The Lower Danube developed to more critical for navigation in concern with the navigation conditions (table 3). The final conclusions about development of the navigation conditions can summarise as follow:
