Living with Landslides: the Ancona Case History and Early Warning System

S. CARDELLINI & P. OSIMANI

Ancona Municipality Monitoring Centre, Ancona, Italy.

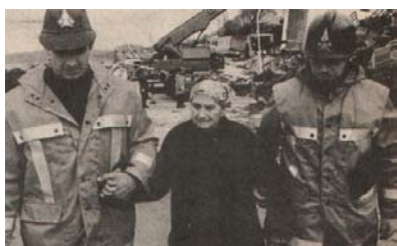
Fig. 1: 1982 event.

An intense landslide affected the northern area of the city, the "Montagnolo" hill started to slide towards the sea. The event involved about 180 m³ during the movement.

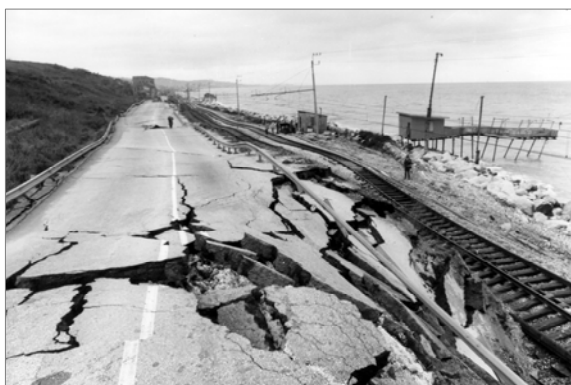
Fig. 2: The National Railway MI-LE (Adriatica) and regional Highway Flaminia.

The National Railway MI-LE (Adriatica) and regional Highway Flaminia slid down 10 meters towards the sea. The movements started from the lower border of the landslide and came up the slope. At the end of the event the movements surveyed were: on the base, max. 8 metres in horizontal and 3 meters in height, while on the top, 5 meters in horizontal and 2.5 meters downwards.

In the morning of 13th December, after a night of uninterrupted movements and noises due to the opening fractures of buildings, the residential districts named "Posatora" and "Borghetto", were evacuated (Figure 2).

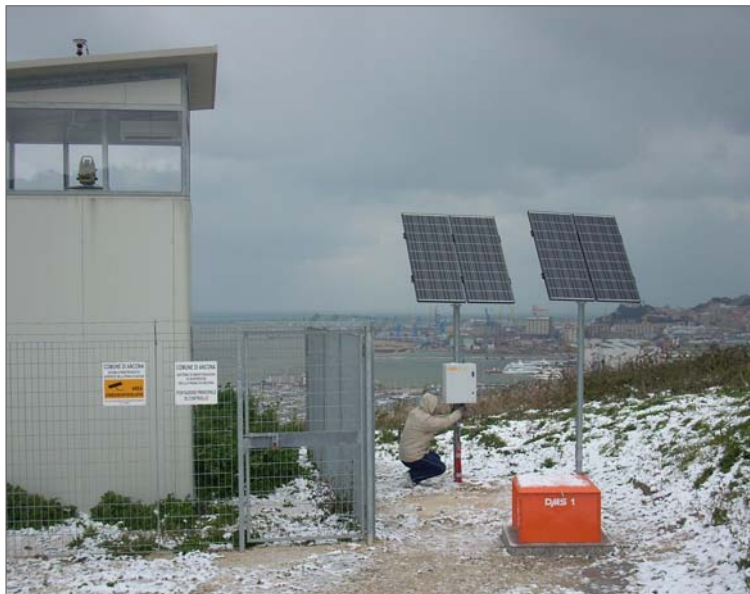
Fig. 4: Surface and geotechnical DMS-systems (Via delle Grotte site).

The surface monitoring system is based on 7 Automatic Robotic Stations, 230 reflector points (installed partly on the 64 inhabited houses and on the structures and infrastructures), 26 geodetic GPS, 8 geodetic GPS (dual frequency), 7 high precision clinometric sensors for the stability control of the main stations of the I and II level of the net. The combination of the different instruments: GPS, Automatic Robotic Stations and the clinometric sensors allows us to monitor a great number of points previously identified, to keep them under supervision with different measuring techniques and from different control positions in the three coordinates (3D, X, Y, Z). The adoption of the geodetic GPS at dual frequency assures a high quality of the GPS measures, and a greater versatility of the whole system.

Each DMS column is formed by n°85 Biaxial Inclino-metric modules (range $\pm 20^\circ$, resolution 0.01°), n° 2 Piezometric Sensors (range 100 psi, resolution 0.01 m), n°85 Temperature Sensors (range 0–70°C, resolution 0,1°C) for a total active vertical of 85 metres controlled. Digital compasses are on board, accuracy 1° azimuth.

DMS has been preassembled in the factory and installed in place by a DMS reeler, forming an instrumented column, like a spiral cord, connecting the required number of modules, each containing one or more geotechnical-geophysical sensor and the electronic boards for data collection and transmission.

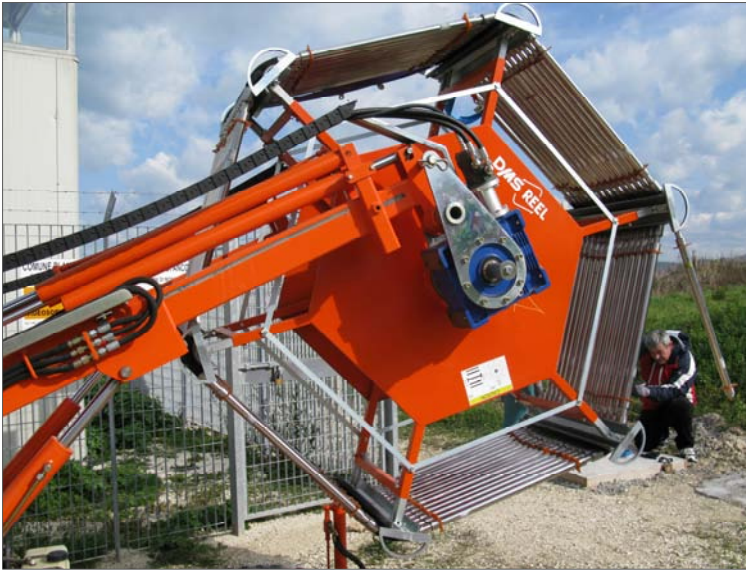
Fig. 5: DMS installation stroke.

The modules are linked by special 2D/3D flexible joints that allow strong, continuous adaptability to bends and twists of the borehole, whilst maintaining rigorously the orientation with respect to a reference system defined during installation.
