GEOLOGICAL CONTROLS ON SLOPE DEFORMATIONS IN THE KÖFELS ROCKSLIDE AREA (TYROL, AUSTRIA)

Christoph PRAGER^{1(2*)}, Christian ZANGERL¹ & Thomas NAGLER³

ABSTRACT

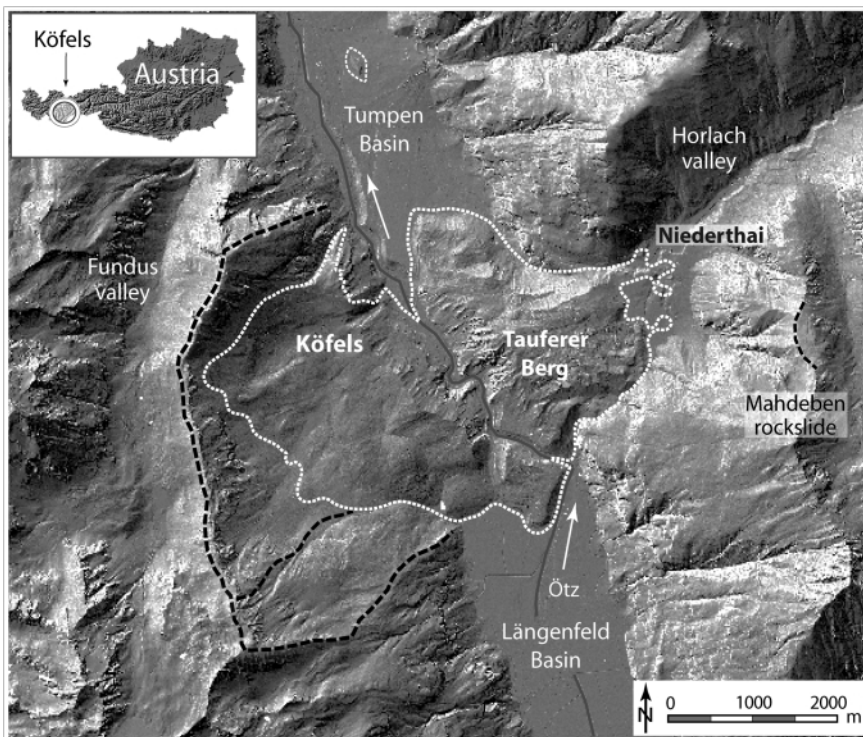
FIGURE 1: Shaded relief map (airborne laserscanner image; Tiris, 2009) showing the scarp (black stippled) and accumulation area (white stippled) of the Köfels rockslide, as well as the backwater areas in the Ötz valley (Tumpfen and Längenfeld basin) and Horlach valley (Niederthai area). Note isolated Toma hill in the Tumpfen basin (location Lärchenbühel).

The Köfels rockslide detached along an east-facing slope from the mountain ridge between Wenderkogel (2200 m) and Pt. 2733 m (near Hohe Seite, 2852 m), leaving a giant amphitheatre-shaped niche (Figs. 1-3). The accumulated debris, covering at least 11.5 km², blocked both the main Ötz valley and the opposing mouth of the W-trending tributary Horlach valley, making up the huge debris ridge of the Taufererberg (Wolfs-egg 1680 m; Figs. 1, 4).

Another striking feature of the Köfels rockslide mass is the occurrence of widely spread rockslide-dammed backwater-deposits (Fig. 1). In the southerly adjacent Längenfeld basin, the extensive geological subsurface investigations for an abandoned hydropower project showed that the fluvio-lacustrine deposition sequences accumulated here up to at least 135 m thick, comprising fine-grained backwater sediments of up to 92 m in thickness. Reflection seismic measurements yielded evidence that the

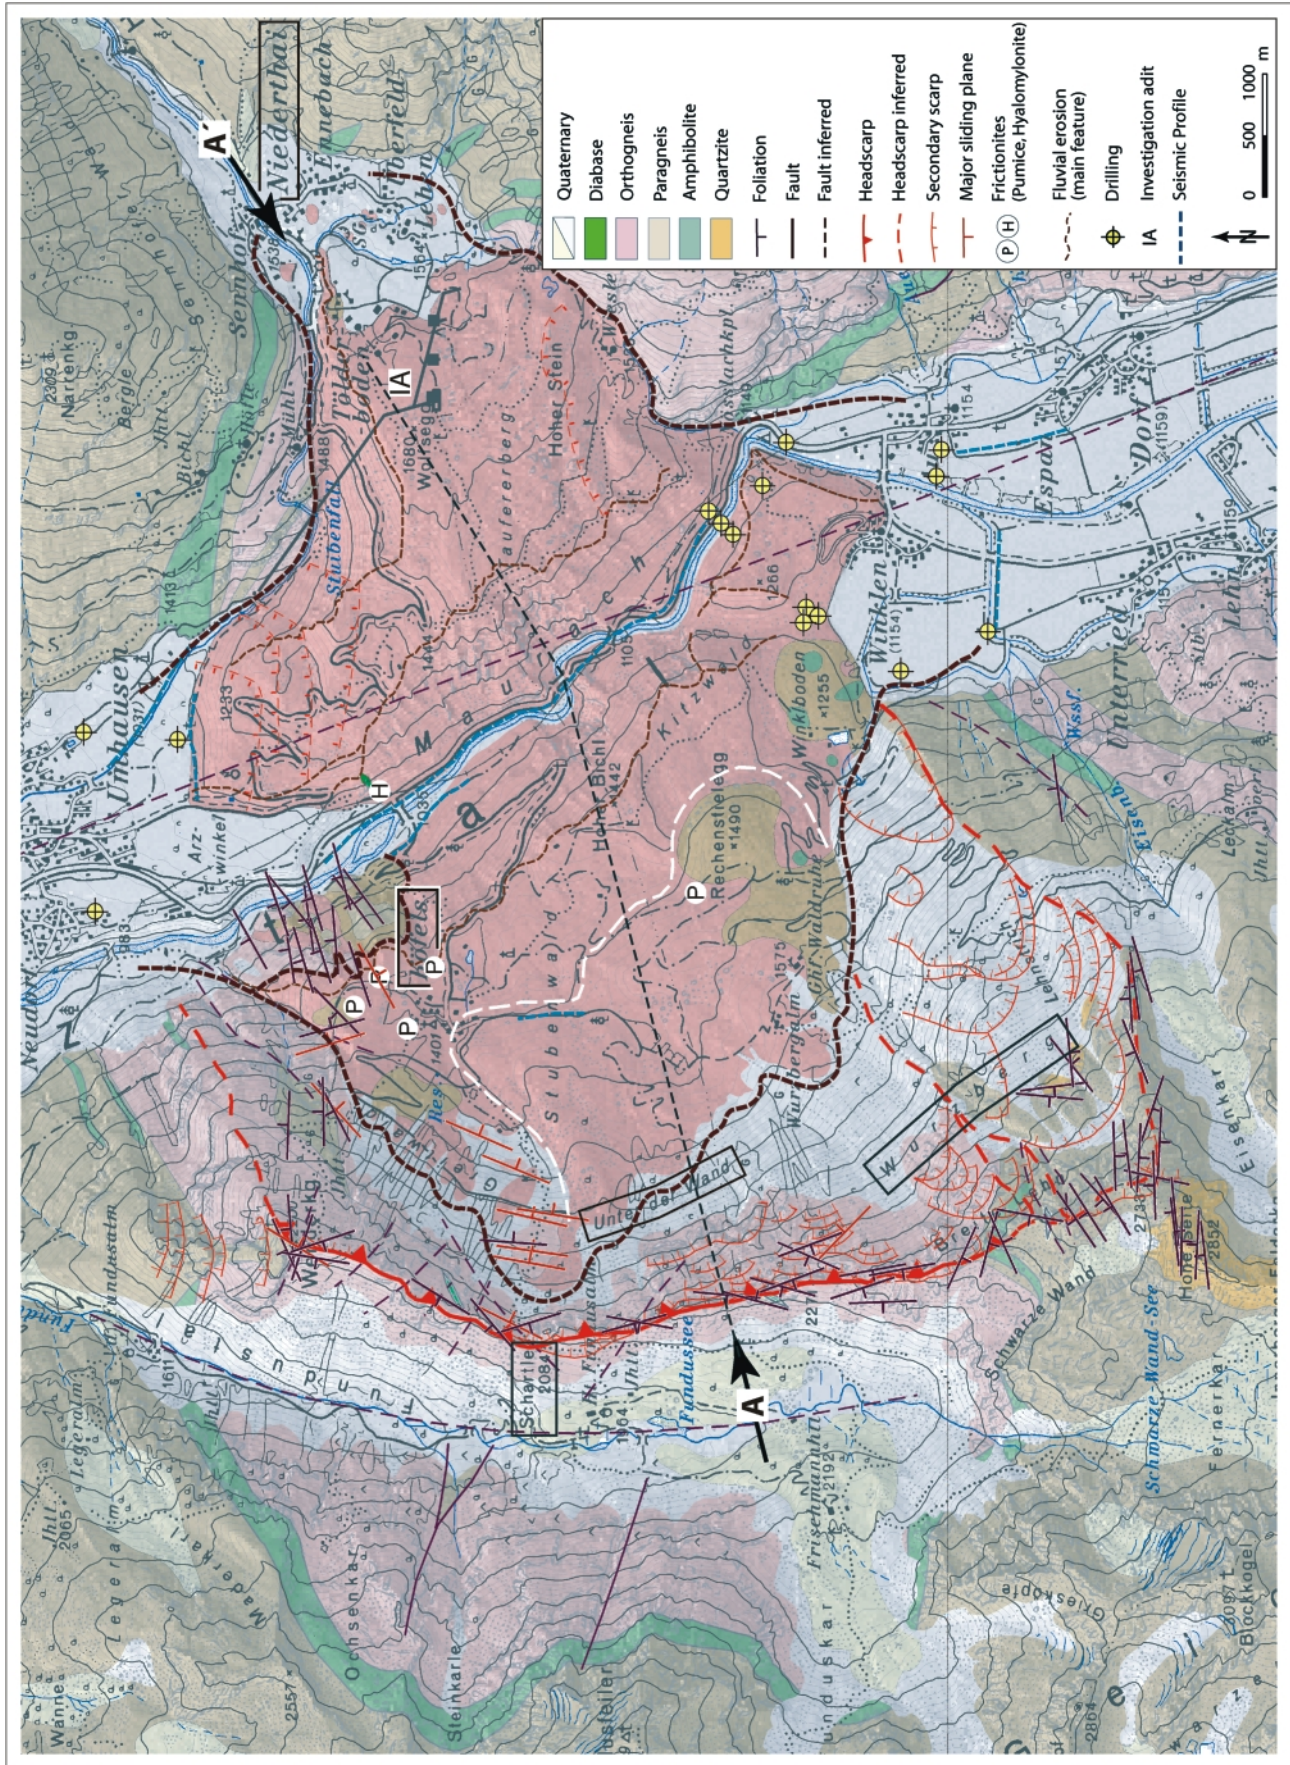
FIGURE 2: Geological map of the Köfels rockslide area. Frictionites (Preuss, 1974; Masch et al., 1985), drillings (Kleblsberg, 1951; Brückl et al., 2001), investigation adit (IA) Horlach valley, i.e. place of finding of C-14 dated wood fragments buried by the rockslide deposits (Heuberger, 1966) and seismic lines (Brückl et al., 2001) depicted according to the references cited. Displaced rockslide masses enveloped stippled dark red; inferred secondary failure event southwest of Köfels (white stippled) according to Hermanns et al. (2006) and own observations. A-A': cross-section (Figs. 9, 10).

Detail lithological and structural mapping led to a comprehensive geological map of the scarp and accumulation area of the Köfels rockslide (Fig. 2). The geological field data were completed by analysing optical colour images and airborne laserscanner images (Tiris, 2009) as well as geological cross-sections. The topographic surface lines of latter were derived from high-resolution airborne laserscanner data (LiDAR), with an accuracy of at least 1 measurement point per 1 m² at elevations up to 2000 m asl and 1 point / 4m² above 2000 m asl respectively (Amt der Tiroler Landesregierung, flyover 2006), and yielded valuable information concerning the morphological and structural characteristics of the rock slopes deformation behaviour.

In the Köfels area the slope bedrock is comprised of three major lithological and structural bedrock units, all several hundred metres thick, which are i) a paragneiss series including amphibolites in the Wenderkogel area and further north, ii) a granitic orthogneiss complex in the northern to central scarp area, extending from Wenderkogel in the north to Wurzburg in the south and iii) another paragneiss series including amphibolites and quartzites, extending from Wurzburg to Hohe Seite in the south (Fig. 2).

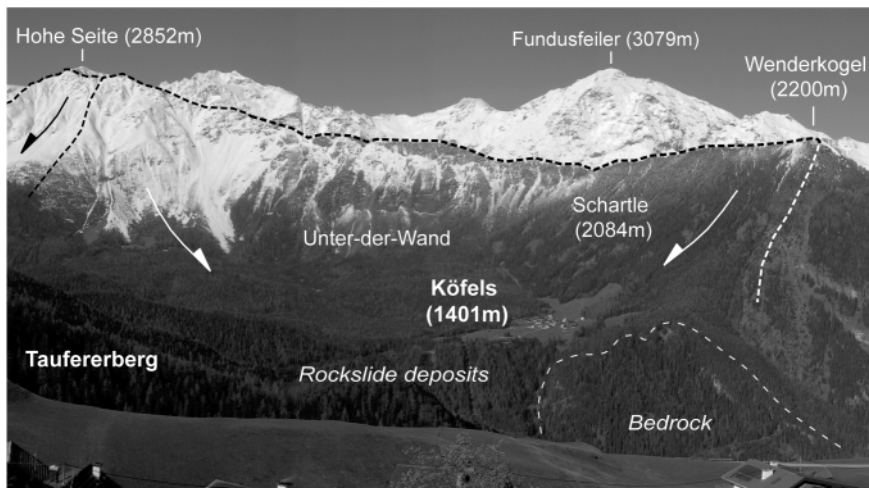
FIGURE 3: Scarp and proximal accumulation area of the rapid Köfels rockslide (view from Höfle/Niederthai towards SW). Indicated are in-situ bedrocks below Köfels, slope collapse between Wenderkogel and Hohe Seite (white arrows) and slowly creeping paragneiss rockslide (black arrow) at the Hohe Seite area (cf. Fig. 2).

The well-exposed head scarp of the Köfels rockslide is characterised by an east-facing amphitheatre-shaped niche (Figs. 1-3). Its western boundary is clearly traceable along the sharp mountain ridge, extending from Wenderkogel along the incision Schartle towards Hohe Seite. The northern scarp flank is morphologically less evident, but situated somewhere in the steep and rugged rock slope northeast of Wenderkogel. The southern boundary of the Köfels niche was previously not clearly defined, but was depicted in a few maps to extend from Pt. 2733 (northeast of Hohe Seite) down slope along a broad east- to northeast-trending ridge (Brückl et al., 2001; Hermanns et al., 2006). This lateral boundary is of major importance for the geological slope model, failure mechanisms

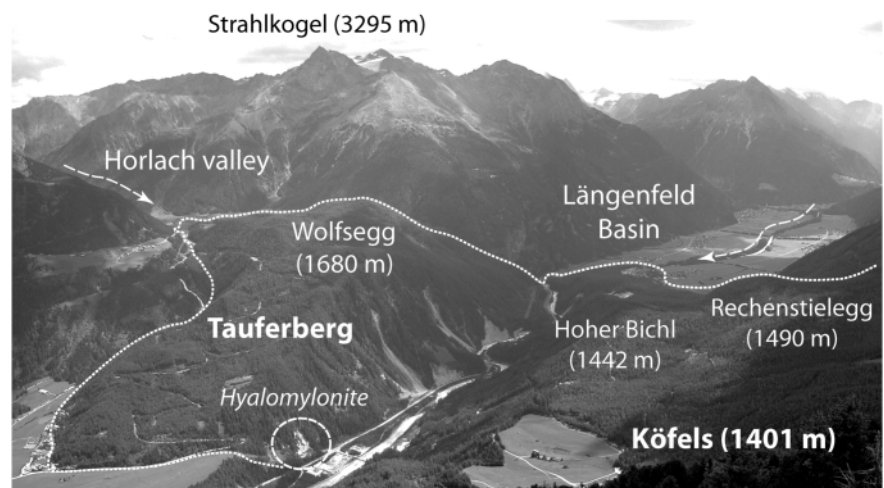
FIGURE 4: Main accumulation area of the Köfels rockslide showing several hundred metres thick deposits and therein incised river Ötz with rockslide-dammed Längenfeld basin in the background.

However, the failing rock masses crossed the Ötz valley, hit their opposite slope and were piled up as a remarkably thick debris ridge, which makes up the Taufererberg (Figs. 1, 2, 4, 9). According to the mechanical model by Erismann et al. (1977) and Erismann and Abele (2001), due to this impact the rockslide mass was separated in to two main units: a lower one, which was blocked by the opposite slope, and an upper one that continued moving further east till Niederthai; in between, a secondary shear zone featuring the well-known frictionites was postulated. So far, the existence of this secondary sliding plane has been subject to dispute but neither been coherently verified nor falsified (Brückl et al., 2001; Hermanns et al., 2006). Rather the rockslide deposits exposed along the deeply incised fluvial canyon Maurach (see Sect. 4) feature relative homogeneous slopes with constant inclinations and do not yield morphological evidence (e.g. slope breaklines, terrain flattening, vegetation changes, spring lines etc.) for the presence of major subhorizontal internal sliding planes, along which intensely disintegrated and/or fused rocks are expected to occur.

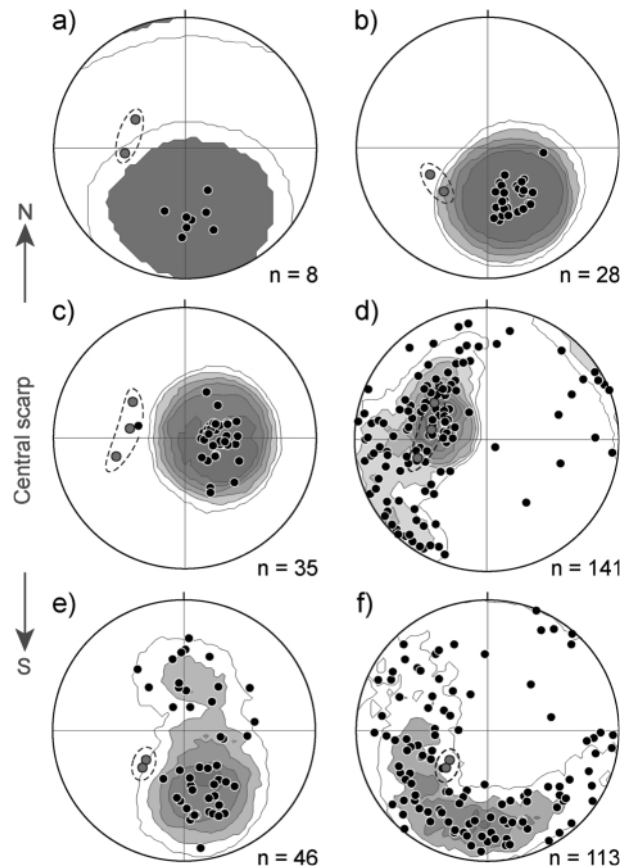
FIGURE 5: Measured discontinuities (black, poles to planes, lower-hemisphere) and mean slope orientation (grey, poles to planes, stippled enveloped) of the Köfels rockslide scarp area: foliation of a) paragneisses in the northern scarp area (Wenderkogel), b) para- and orthogneisses at the slope northeast of Köfels, c) orthogneisses in the central scarp area and e) paragneisses in the southern scarp area (Hohe Seite), as well as fractures of d) orthogneisses in the central scarp area and f) paragneisses in the southern scarp area.

meso-scale tensile joints and shear fractures are encountered in both the ortho- and paragneissic bedrocks. Several discontinuities are coated with chlorite, a few only with quartz. Fault gouges, kakirites or noticeable fault breccias have not been observed so far. The collected field data from the orthogneisses (og) at the SE- to E-dipping slope of the northern and central scarp areas show a scattered spatial distribution (girdle distribution). However, based on overall geological field observations and statistical cluster analyses, four main fracture sets were differentiated (Fig. 5, Tab. 1).

Discontinuity set	Orientation (trend)	Statistical mean	n	Remarks
foliation og (Fig. 5c)	NE-SW to N-S to NW-SE	272/20	35	W-plunging antiform
foliation og/pg (Fig. 5b)	E-W to NE-SW	334/35	28	
og#1 (Fig. 5d)	N-S	97/32	57	major sliding planes
og#2 (Fig. 5d)	N-S	90/76	23	head-scarp deformation
og#3 (Fig. 5d)	NW-SE	47/83	32	orientation Ötz valley
og#4 (Fig. 5d)	NE-SW	152/52	29	
foliation pg (Fig. 5a)	E-W	354/46	8	
foliation pg (Fig. 5e)	E-W	341/42 (and 187/34)	46	W-plunging fold axes
pg#1 (Fig. 5f)	N-S	104/41	31	
pg#2 (Fig. 5f)	E-W	356/61	30	
pg#3 (Fig. 5f)	NW-SE	40/70	27	orientation Ötz valley
pg#4 (Fig. 5f)	NE-SW	300/77	25

TABLE 1: Compiled mean orientations of discontinuities measured in ortho- (og) and paragneisses (pg) at the Köfels slope. Foliation differentiated for areas Schartle - Unter-der-Wand (Fig. 5c), bedrock slope northeast of Köfels (Fig. 5b), Wenderkogel (Fig. 5a), Hohe Seite - Wurzburg (Fig. 5e). Statistical mean values (azimuth/dip) of foliation and fracture sets based on cluster analyses (Giné statistic; see also Fig. 5).

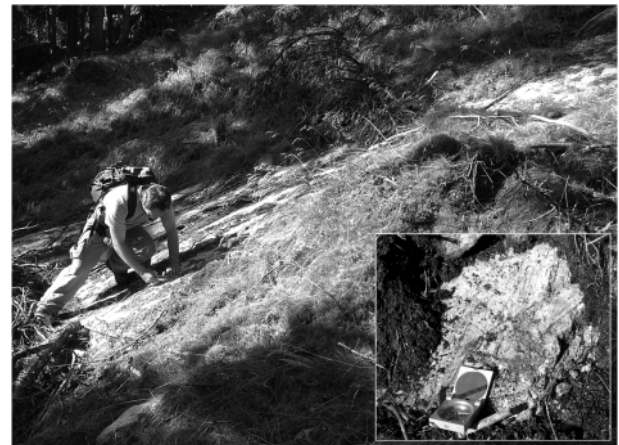
FIGURE 6: In-situ orthogneiss with gently E-dipping (mean azimuth/dip: 100/30), polished major sliding plane of the Köfels rockslide (between Köfels and Schartle, at approx. 1800 m a.s.l.).

Fracture set og#1 comprises the most striking structural features of the Köfels site, the well-known major sliding planes that are exposed along the path to Schartle (Figs. 2, 6) and forest roads nearby. Here these rather gently inclined key-fractures, featuring a mean orientation (azimuth/dip) of approx. 100/30 and thus day-lighting sub-parallel to the east-facing slope, show remarkable planar surfaces (Preuss, 1986) and trace lengths of up to several tens of metres. Some of these weakness planes are slickenside coated with quartz, a few exhibiting thin cataclasites (attrition breccias) and others featuring unpolished i.e. rather rough surfaces. Commonly they are devoid of significant striations, but polished and thus showing evidence for shear deformation, most likely of tectonic origin (see Sect. 7) and/or due to the rockslide event. South of the Schartle - Köfels area, the moderately dipping fractures og#1 obviously decrease in size, density and frequency of occurrence. Other brittle major fault zones of comparable spatial extent, and causing such distinct rock strength anisotropy, are not encountered in the scarp area. Fracture set og#2 comprises steep N-S-striking planes and may be associated with the deeply incised N-trending Fundus valley west of the Köfels scarp (Figs. 1, 2). Central sections of the Köfels head scarp, especially the subvertical rock walls at the location Unter-der-Wand (Fig. 7), exhibit relatively intact orthogneisses that are cut by approx. 60-80° E-dipping main fracture zones. Posing preferred zones of rock weakness, these discontinuities favoured the observed gravitational slope deformations (see Sects. 6, 7). Fracture set og#3, i.e. steeply NW-trending discontinuities, is obviously orientated sub-parallel to the central Ötz valley and corresponds to the present-day stress field, with a maximum principal horizontal stress orientated NNW-SSE (Drimmel, 1980; Heidbach et al., 2008). This and the tempered spring "Bad Längenfeld" (southern Längenfeld basin, cf. Fig. 1), which emanates from a NW-trending joint (Zötl and Goldbrunner, 1993), indicate deep-seated flow systems and according permeable main fracture zones. Fracture set og#4 comprises steeply NE-

(Fig. 10) and several outcrops exhibiting stepped rock surfaces show that ca. 25-35° E-dipping major fractures, which daylight on the E-facing slope and form preferred sliding planes (set og#1; Fig. 6), are cross-linked by ca. 60-80° E-dipping (set og#2) and other discontinuities. The coalescence of this fracture network caused bedrock fragmentation into major slabs and slide blocks, generated persistent failure planes and finally determined the block size distribution of the slide debris. The lateral boundaries of the Köfels rockslide scarp were predisposed primarily by the spatial extent of the orthogneisses and its surrounding E-W-trending paragneisses as well as secondary by NE- and NW-trending fracture sets (og#3-4, pg+#3-4), plus random.

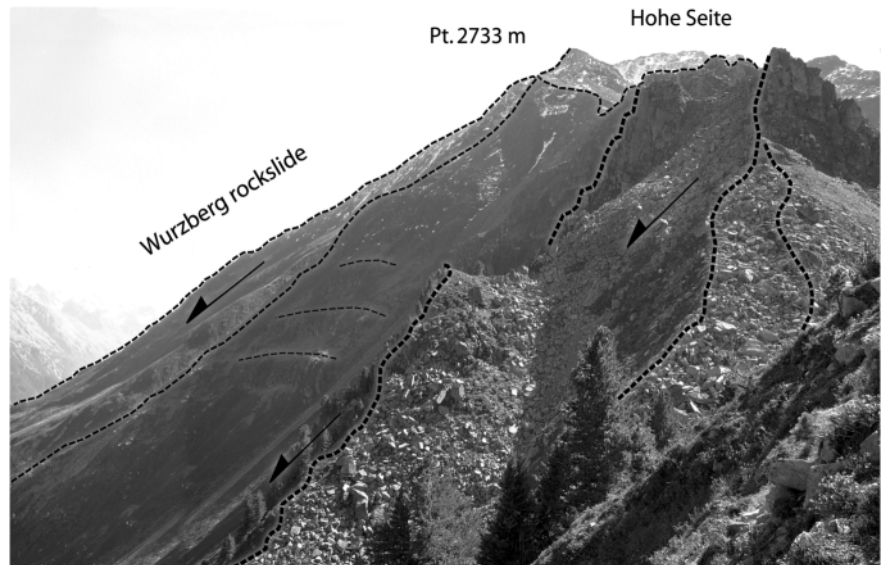
FIGURE 7: Head scarp of the Köfels rockslide (location: top of Unter-der-Wand, approx. 2200 m a.s.l.) showing post-failure deformations of jointed orthogneisses along 60-80° E-dipping main fracture zones. Bedrock disintegration produces coarse blocky talus deposits and causes some minor rock falls. In the background (left skyline) incompetent paragneiss series affected by the slowly creeping Wurzberg rockslide (cf. Figs. 2, 3, 8, 11).

ned (>50° to subvertical) rock walls are cut by several 60-80° E-dipping main fracture zones, which cause E-directed normal faulting of distinct bedrock slabs (Figs. 2, 7, 10). The trace lengths of the individual N-S-trending scarps exceed 500 m, the vertical offsets of the normal-faulted blocks range in the decametre-scale. Evidently the competent orthogneisses deform here along widely i.e. a few decametres spaced main

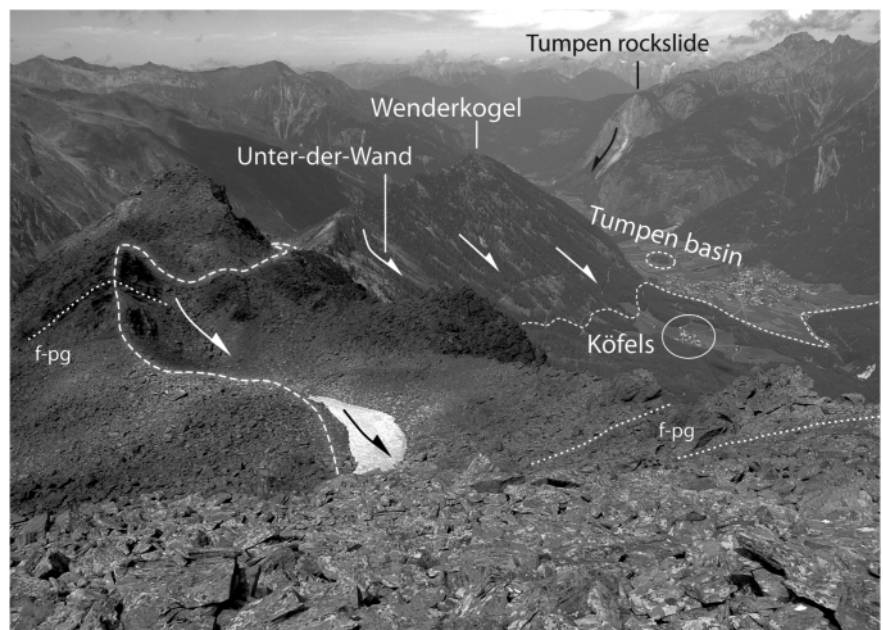
FIGURE 8: Head scarp of the Wurzberg rockslide (near Hohe Seite, view towards North; cf. Figs. 7, 11): fractured paragneiss series (f-pg = trace of foliation; cf. Figs. 5e, f) featuring deep-seated extension zones and NE-facing secondary scarps, with vertical offsets of around a few decametres. Bedrock widely covered by platy talus deposits, with average block sizes being clearly smaller than those of disintegrated orthogneisses (cf. Fig. 7). In the background, orthogneissic scarp and proximal accumulation area of the rapid Köfels rockslide event, as well as isolated rockslide deposits (Toma hill) in the Tumpen basin (Fig. 1).

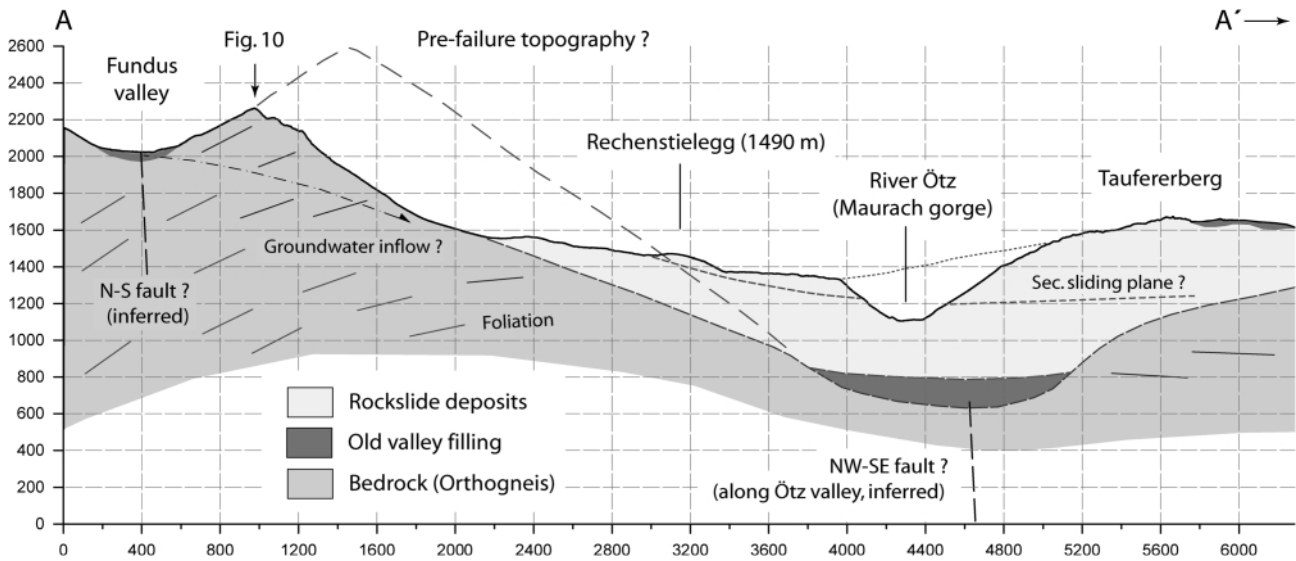
FIGURE 9: Geological cross section of the Köfels rockslide (cf. Fig. 2), with topographic surface line derived from high-resolution airborne laserscanner data (see Sect. 3). Thickness of slide debris according to Brückl et. al. (2001). Potential groundwater inflows (inferred) from the Fundus valley into the fractured bedrock units schematically indicated.

How far the hydrogeological setting, e. g. potential groundwater inflows from the adjacent Fundus valley into the fractured bedrocks in the Köfels area (cf. Fig. 9), contributed to the slope instabilities has not been investigated yet. But the geological field surveys yielded evidence for a close relation between different lithologies, structural setting and slope deformation behaviour. Anisotropic, i.e. structurally controlled, strong rocks, especially at steep slopes featuring high relief energy, generally tend to rapid failure mechanisms such as rock collapses and catastrophic rock slides (Hungr and Evans,

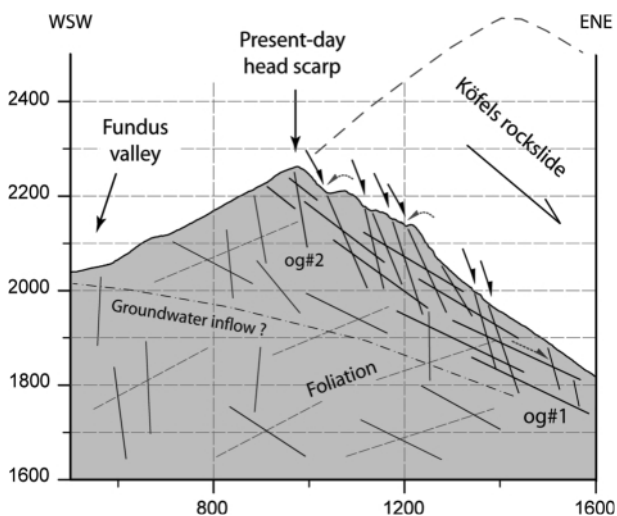
FIGURE 10: Stepped slope profile encountered in competent orthogneisses (location: Unter-der-Wand), indicating post-failure scarp deformation along en-echelon arranged steep fractures (set og#2; cf. Figs. 5, 7, 11) (i.e. zoom-in of Fig. 9, horizontal scaling according to Fig. 9).

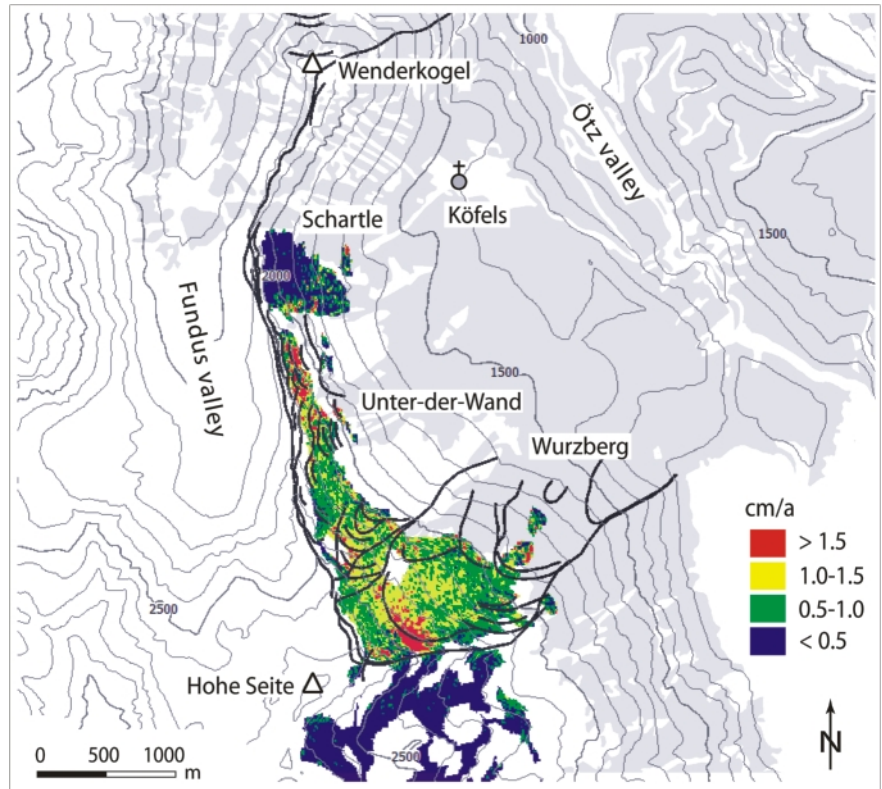
FIGURE 11: InSAR based motion field (surface parallel assumption) derived from ENVISAT ASAR images (acquired on 7 August 2004 and 27 August 2005) showing active rockslides in the Wurzburg and Unter-der-Wand areas. Scarps (black lines) according to field surveys (Fig. 2). At lower slope sections radar signal decorrelations due to dense vegetation (grey; depicted according to Austrian Map ÖK).

slope instabilities have been cross-checked with recent analyses of repeat pass satellite-borne radar (InSAR) images. The available InSAR motion field (Fig. 11) is based on the ASAR image pair 7 August 2004 and 27 August 2005. A Digital Elevation Model with 10 m pixel spacing was used for removing the interferometric phase contributions due to topography. Inaccuracies of the DEM can be neglected as the imaging geometry of the image pair has a low sensitivity to elevation, e.g. one interferometric phase cycle of 2π corresponds to an elevation change of 623 m (height of ambiguity). Another error source might be different atmospheric conditions, especially tropospheric water vapour content, at the time of the two image acquisitions. These effects cannot be removed from a single image pair, but are in general at scales larger than several kilometres or tens of kilometres.

The InSAR based motion analyses show a typical displacement rate of 0.5 to 1.5 cm/a (surface parallel assumption) in the Wurzburg area and in the upper part of Unter-der-Wand. The area below Schartle shows no displacement in the main part, and low displacement rates (< 1 cm/a) in the lower part. At lower sections of the slope (below ca 1800 m) dense vegetation, mainly shrubs and forests, are present, which cause temporal decorrelation of radar signal of the two images permitting the retrieval of motion information (masked in Fig. 11). The size and spatial extent of the motion field indicates, in cross-check with geological field surveys and optical images, that the terrain displacements clearly affect larger bedrock areas. For this study, only one SAR image pair with 1 year time interval was available. The analysis of further SAR image pairs with different time intervals (several months to 2 years) will improve the reliability of the InSAR based motion field, especially when combined with geodetic measurement campaigns, and enables to study the annual velocity variations of the observed rockslides.
