Postglacial landslides and their impact on Pleistocene lake floor deposits in the Balderschwang Valley as witnessed by geomorphological, sedimentological and geophysical evidence (Vorarlberg, Austria)

by Leo W.S. de Graaff & A.C. Harry Seijmonsbergen

VORARLBERGER
NATURSCHAU
9
SEITE 237-251
Dornbirn 2001

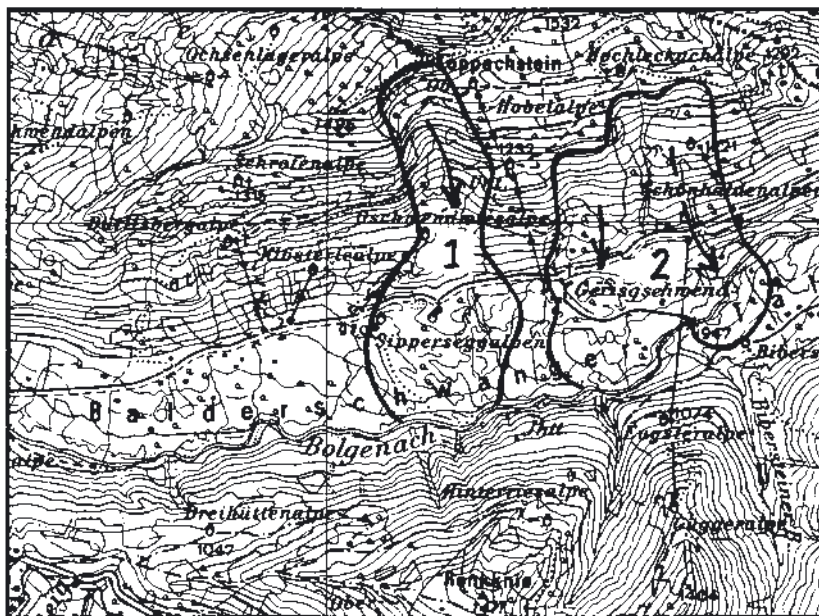
Figure 1: Location of the study area in the valley of Balder Schwang.
 1 = western central landslide area near "Gschwendwiesalpe" and "Sipperseggalpen"
 2 = outline of the complex landslide in the eastern part near „Schonhaldenalpen“ and „Gerisgshwend“

Two major and some smaller landslides came down on top of the lacustrine deposits in the Austrian part of the Balderschwang valley and strongly affected the geomorphology of the valley (see *figure 1 for location*). These slides were

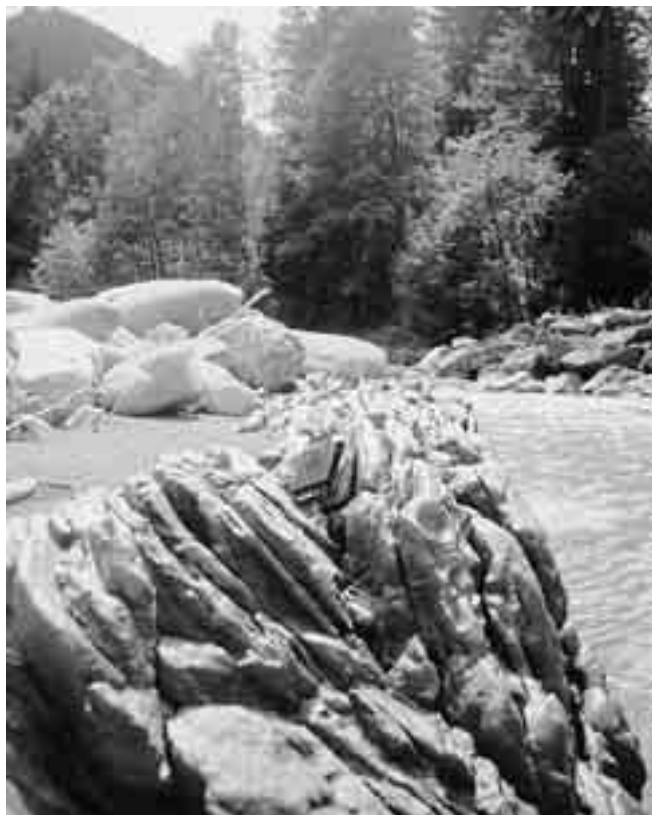
Figure 3:
Photo along the Bolgenach near the bridge at point 947 in the eastern part of landslide 2 in the map in *Fig. 1*. Deformed and tilted clays are exposed as the result of the landslide impact from the northern valley slopes.

This sandstone slide had an enormous impact on the valley floor, squeezing out and pushing up the lake floor deposits (silty clay) into a curved clay ridge, which still exists at the southern side of the river. This pressure ridge rises tens of meters above the riverbed; a single farmhouse has been built on top of it. Landslide material at the surface is not present at this side of the river. Instead, patches of fluvial gravel and sand were found against the inner side of the ridge. At this side the ridge later became strongly transformed by slumping of material, a process that is still active. In fact, the Bolgenach found a new course and incised again, almost along the outer contact of the landslide mass with the deformed and tilted lacustrine sediments. At the outer side, near the farmhouse, the ridge is hardly affected by mass wasting and erosion.

Towards the southwest, the pressure ridge ends in contact with younger alluvial fan deposits transported by a tributary stream. Coming closer to its confluence with the Bolgenach, the pressure ridge is fully cut off by fluvial erosion, but outcrops of the disturbed 'younger' lake floor deposits still can be observed here, at the southern side of streambed of the Bolgenach. Sediment layers of these lacustrine deposits are exposed in steeply inclined to almost vertical positions. These layers run almost parallel to the riverbed and they show internal folding and other disturbances like shear planes (see photo in *fig. 3*). For a few years, relicts of these 'younger' Pleistocene sediments were also exposed in contact with upthrust subglacial till and 'older' lacustrine deposits.
